Annual Review

Erskine Park Waste Transfer Facility

Date:	July 2022
Prepared by:	Talis Consultants Pty Ltd and Cleanaway Waste Management Pty Ltd
Version:	Final

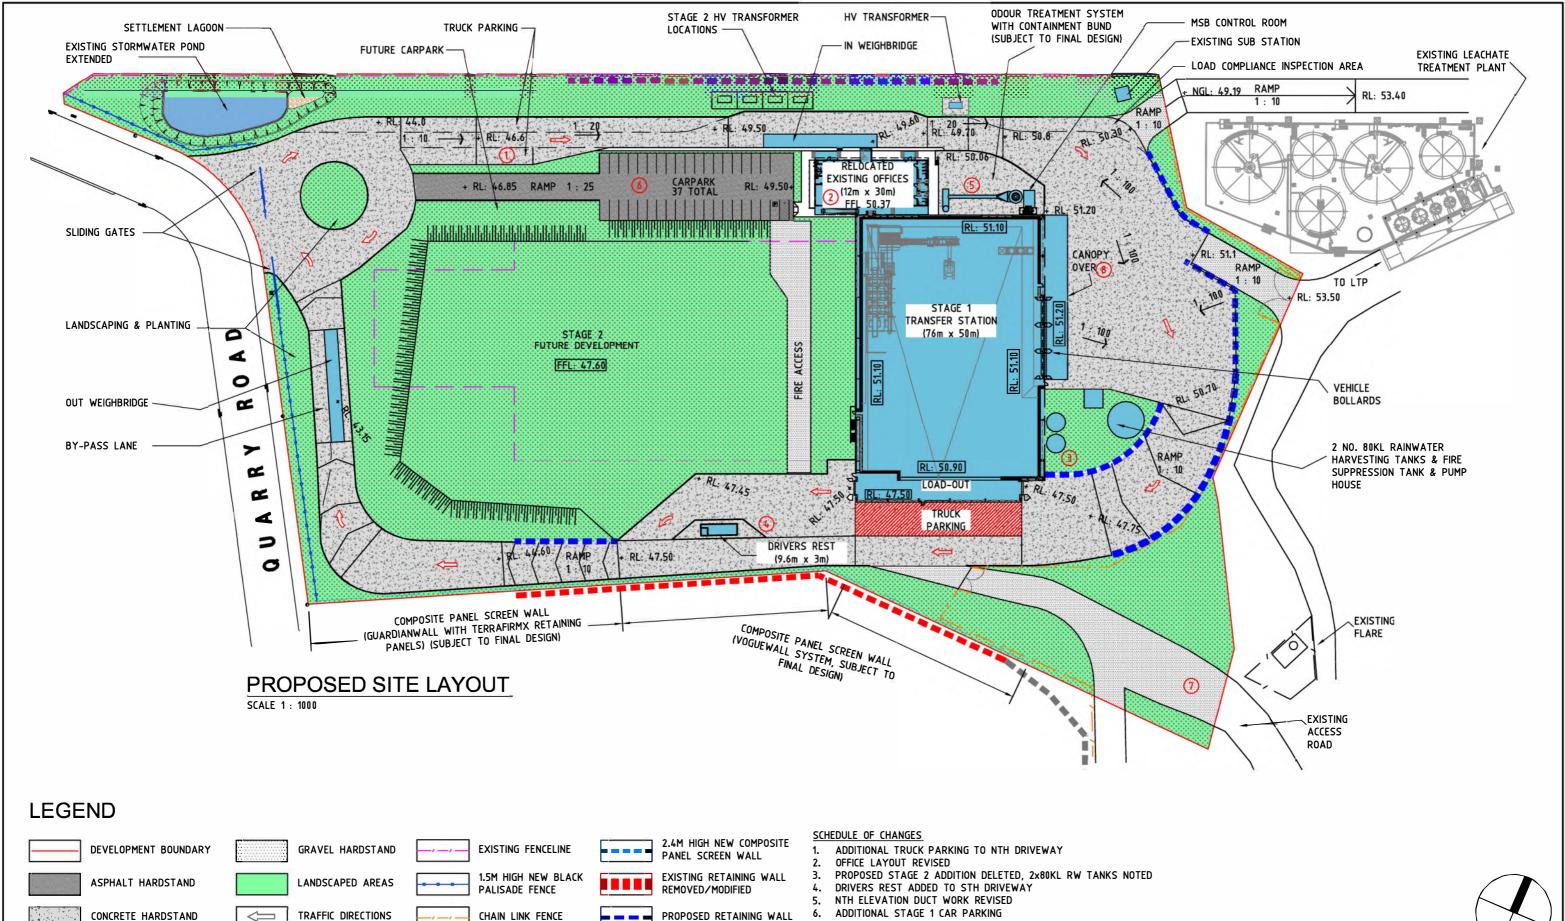
Waste delivery vehicles enter the site from Quarry Road and weigh on the incoming weighbridge located adjacent to the office. Delivery vehicles then proceed to the eastern side of the building where they align with one of the roller shutter door entrances on the eastern elevation. The vehicles reverse through one of the rapid acting roller shutter doors, discharge their waste and then drive out of the building, down a ramp and proceed to the south of the transfer station towards the outgoing weighbridge, exiting the site onto Quarry Road. The majority of the material received is waste from commercial waste collection trucks, stationary compactor (packer) hooklift loads and side-loader collections (e.g., 240L mobile garbage bin collections from commercial premises).

Waste offloaded on the tipping floor is separated into two categories: putrescible and non-putrescible waste, including wood, masonry, rigid plastics, and old corrugated cardboard. The non-putrescible waste is sorted for recycling, while the remaining waste is consolidated with the putrescible waste and transferred into transfer vehicles by a front-end loader which lifts the material over a wall opening for top loading.

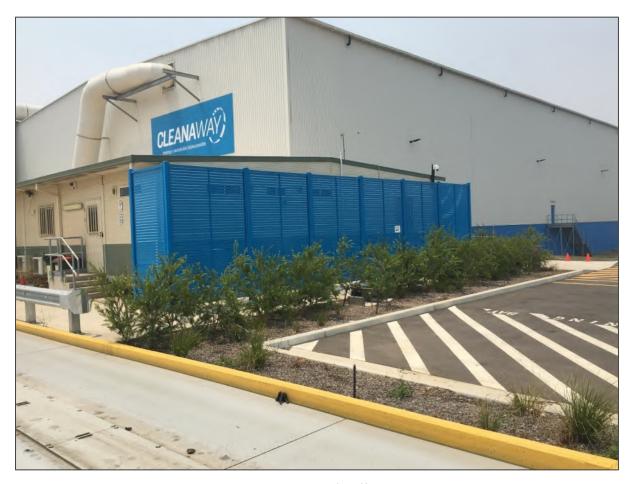
Photo 1 Screen and Landscaping Adjacent to the Site's Office

Management and mitigation measures were implemented at the site during the reporting period to minimise direct and indirect impacts on visual amenity, in accordance with the OEMP (SLR 2018a). The screen adjacent to the site office (refer to Photo 1, below) and the landscaping at the site was maintained during the reporting period.
