OCTOBER 2022

Community newsletter

CLEANAWAY
Making a sustainable future possible together

New Chum Landfill prepared for wet season

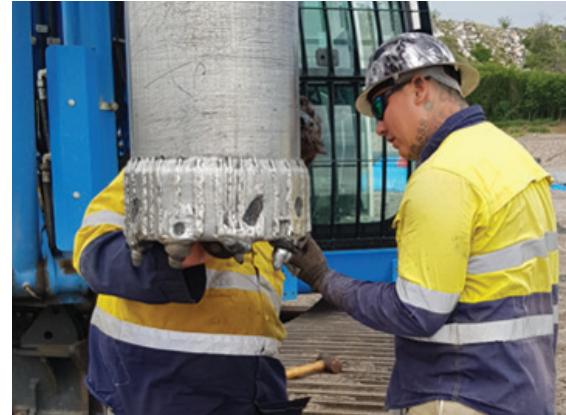
Cleanaway has drilled and installed 28 landfill gas wells since beginning a program in August to extend our network of landfill gas (LFG) management wells at New Chum. The program is on track to have more than 35 more wells drilled by mid-December, adding to the 63 already in operation.

Landfill gas is produced in all landfill sites by decomposition of organic matter and is composed mostly of methane and carbon dioxide. While these gases do not smell, other landfill gases may cause an odour if not captured. Cleanaway seeks to safely collect and burn the landfill gas.

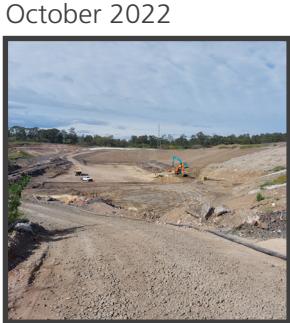
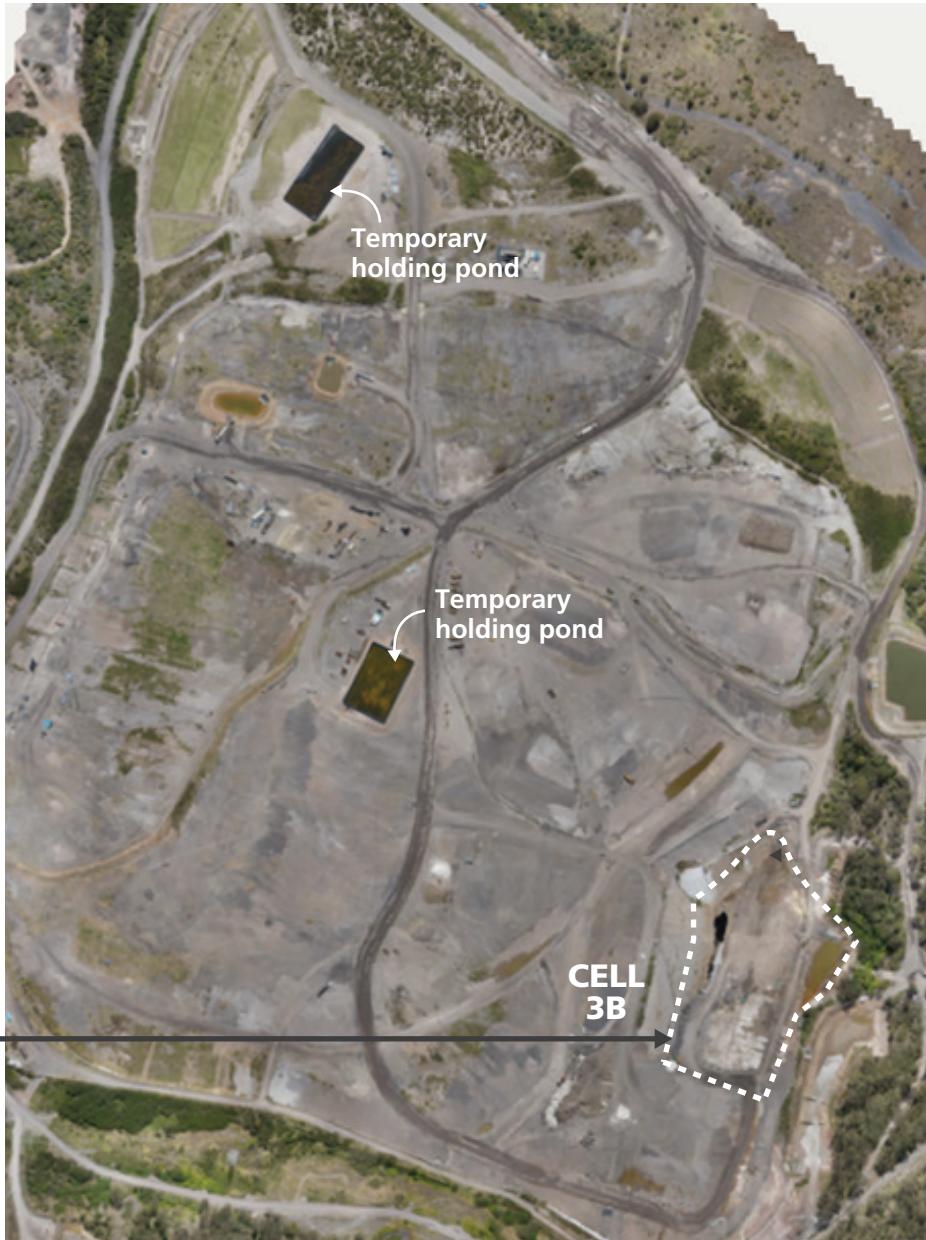
Transformation of the cell flooded earlier this year

Cleanaway's progress in removing stormwater from Cell 3B, which was inundated by the February floods and subsequent severe wet weather events in March and April 2022, is shown above. The images at the top show the cell at the height of the stormwater in March and, earlier this month, following removal of that water and remediation of the cell. The main image shows the entire landfill site. Significant works have been carried out to divert stormwater away from the cell, which is at the lowest point of the site. Any water that does gather in the cell can be removed to the temporary holding ponds highlighted.

Significant stormwater diversion works have been carried out to minimise further pooling of water in the cell, which is at the low point of the site. To ensure we can efficiently remove and appropriately manage any water that does gather in the cell, we have constructed temporary holding ponds as a contingency.

In addition, we are preparing to install an engineered protective layer of high-density polyethylene (HDPE) plastic on the walls of the cell to prevent any stormwater that gathers from coming into contact with waste in adjacent cells.
