# TULLAMARINE CLOSED LANDFILL ANNUAL COMPLIANCE REPORT 2020

Presentation to Tullamarine Landfill Community Consultation Group

Mark Walker, Michael Stewart  
10/08/2021

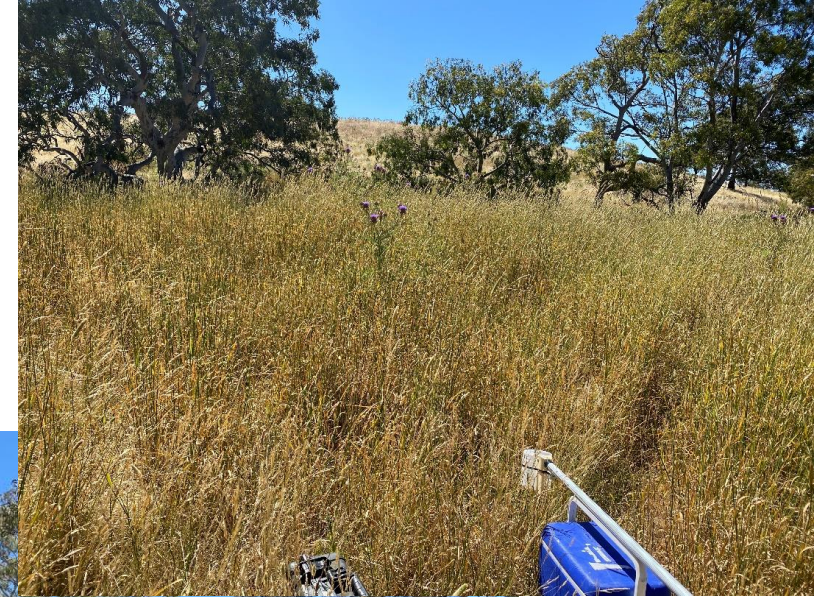
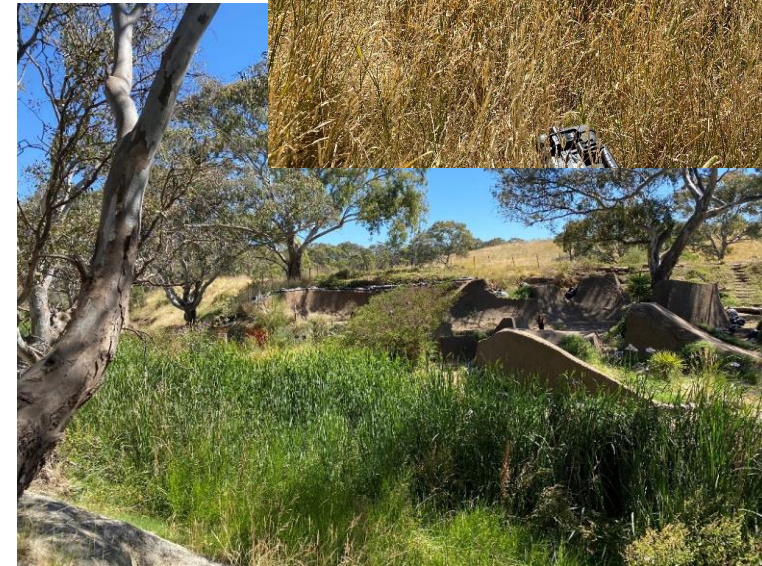
Examples of overgrown vegetation at the Moonee Ponds Creek

- unable to sample L01, L02, L03, L12 and L14 (sump infrastructure and damaged sample equipment)
- unable to sample L06 (blockage), unable to sample leachate from WELL15 (LNAPL to base of well)
- unable to monitor 4 SW locations (overgrown vegetation)

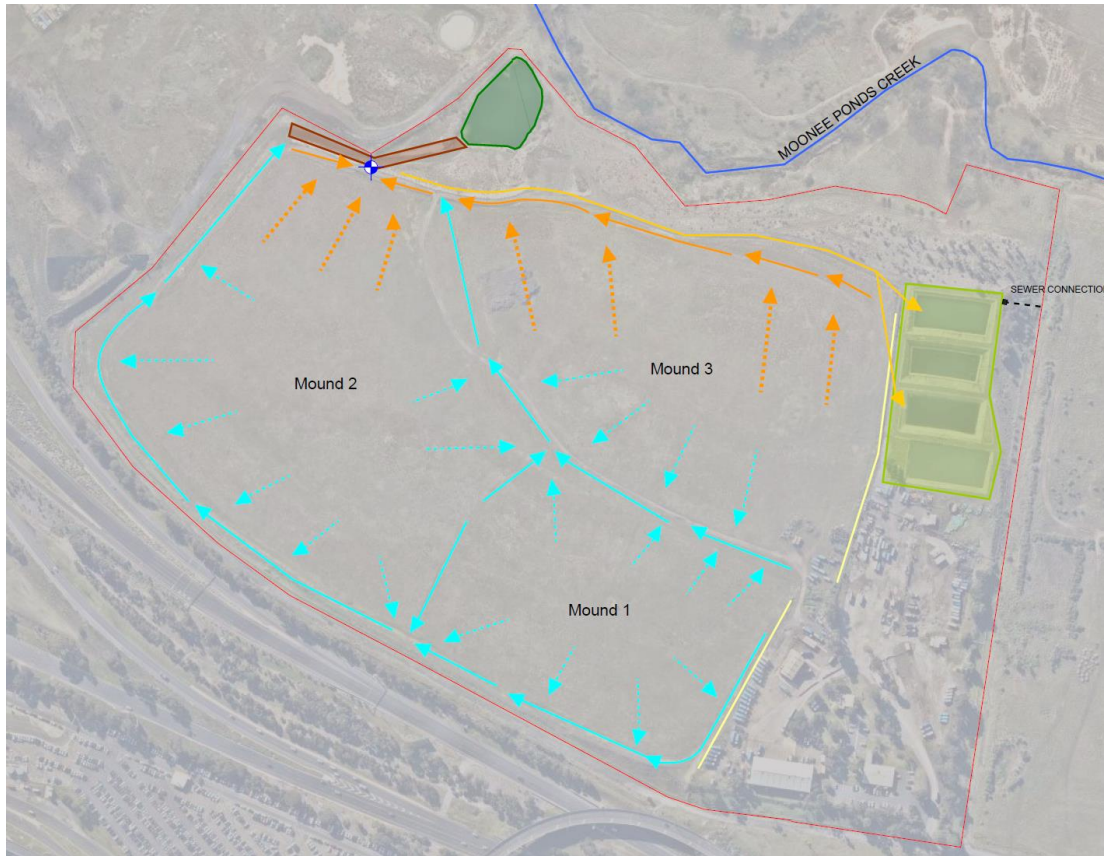
## Q1) STORMWATER FLOW

Both are correct. Stormwater at the site flows to the Rock Pond and the settling ponds, based on where the stormwater is collected on site.

This figure demonstrates that stormwater collected at the southern and western landfill perimeter (in blue) is directed to the Rock Pond, while stormwater collected at the northern landfill perimeter (in orange) is directed to the settling ponds.

PFAS was detected in all surface water monitoring locations (which are along the Moonee Ponds Creek) over the reporting period. As previously presented, stormwater from the cap is captured in the Rock Pond and the settling ponds.

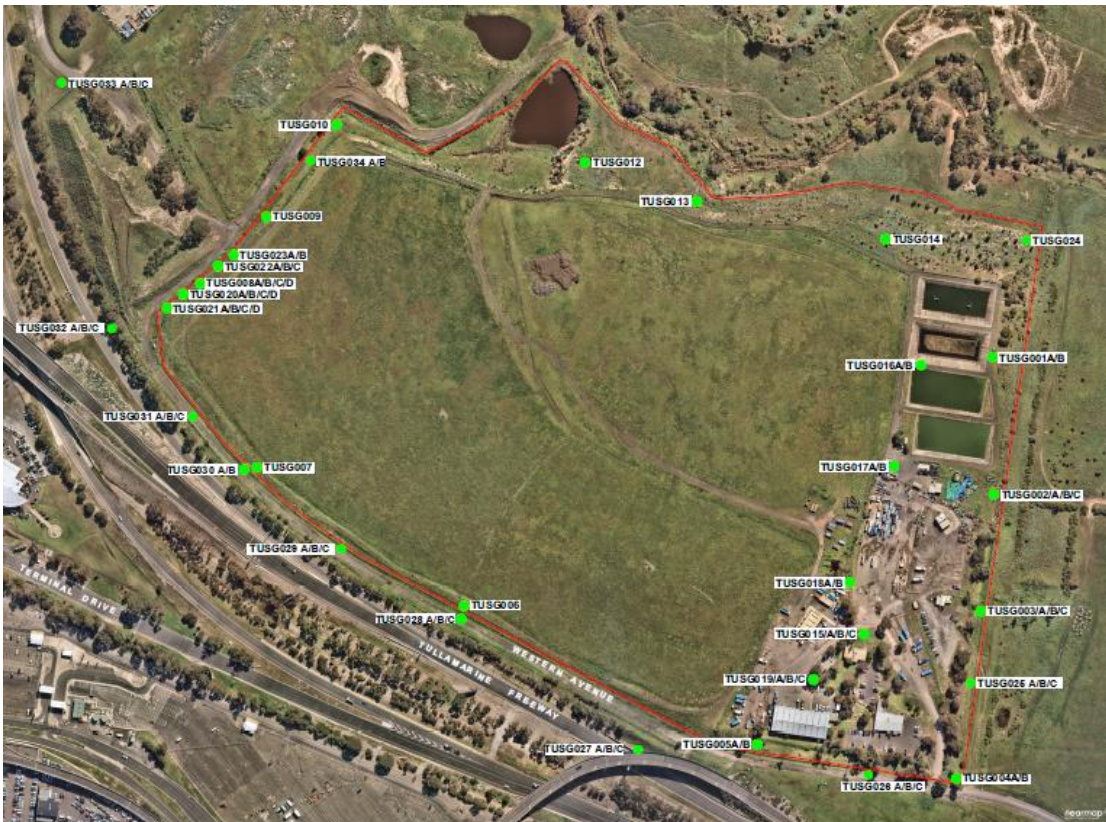
## Q2) LANDFILL GAS MONITORING NETWORK

All bores installed are perimeter gas bores (>20 m from waste). The term ‘perimeter bore’ is used to describe a landfill gas bore that is used to assess landfill gas within ‘subsurface geology at the landfill boundary’ as per the EPA landfill guidelines.

The location of all landfill gas bores is provided on Figure 7 of the ACR and is repeated here.

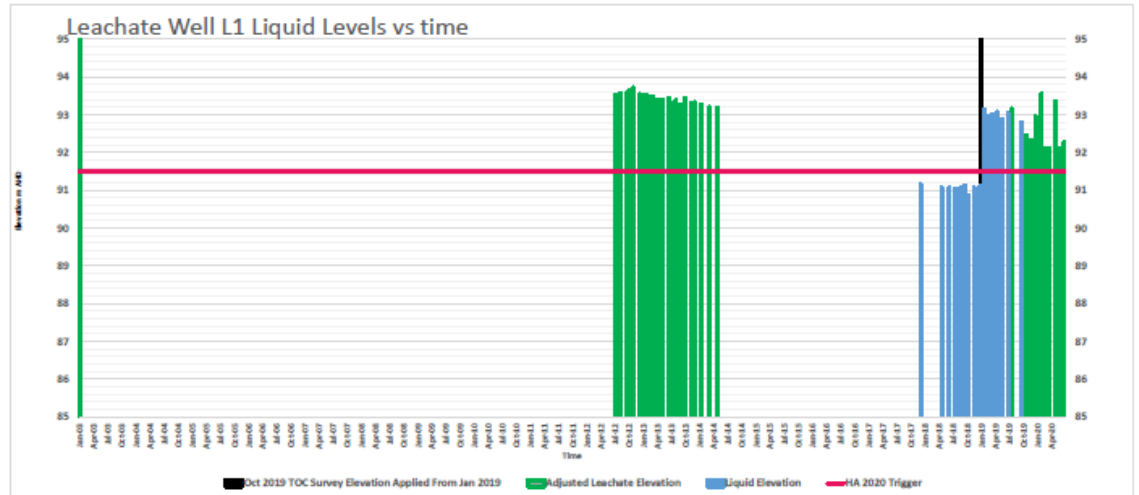
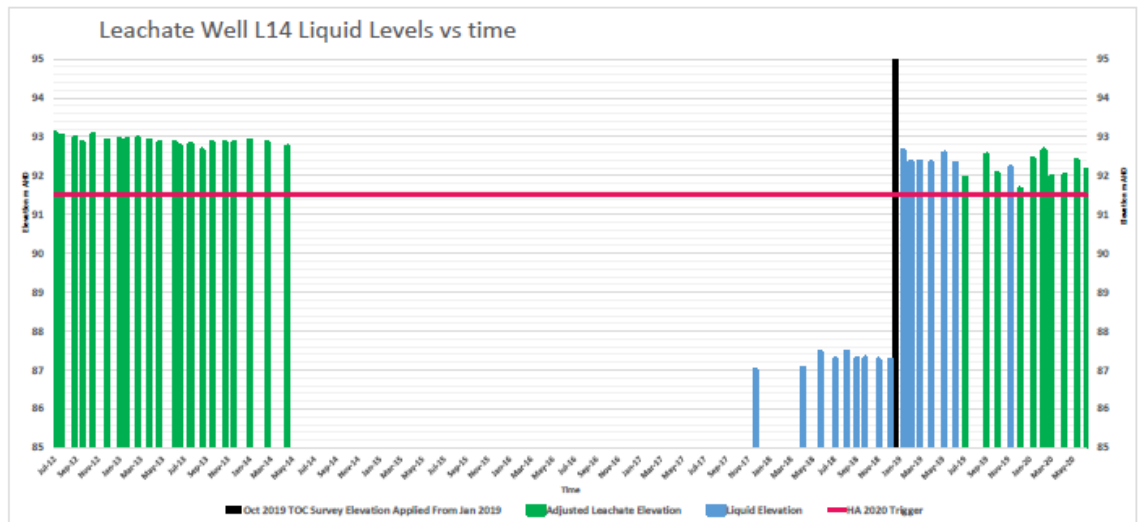
These charts (taken from the 2019 Audit report) show the liquid levels in two of the sumps (L01 and L14). The data gap between mid 2014 and early 2019 is due to an issue with the survey elevation for the sumps.

The data demonstrate a slowly decreasing trend. The breaching of target levels is not suggesting that leachate levels have increased. Leachate levels have always been above the target levels.

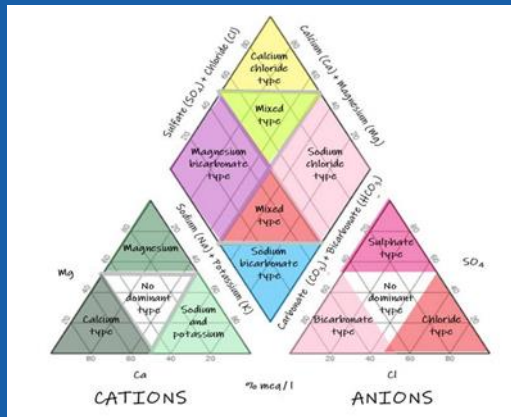
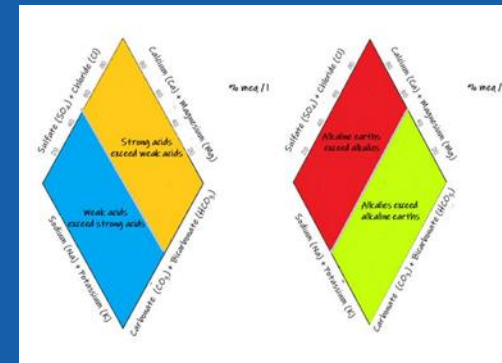
Q7) *Would it possible to get a simple plain language explanation or presentation of how Piper Diagrams work and how an expert would interpret such diagrams referring to the importance or otherwise of the coloured areas as per the diagrams below.*

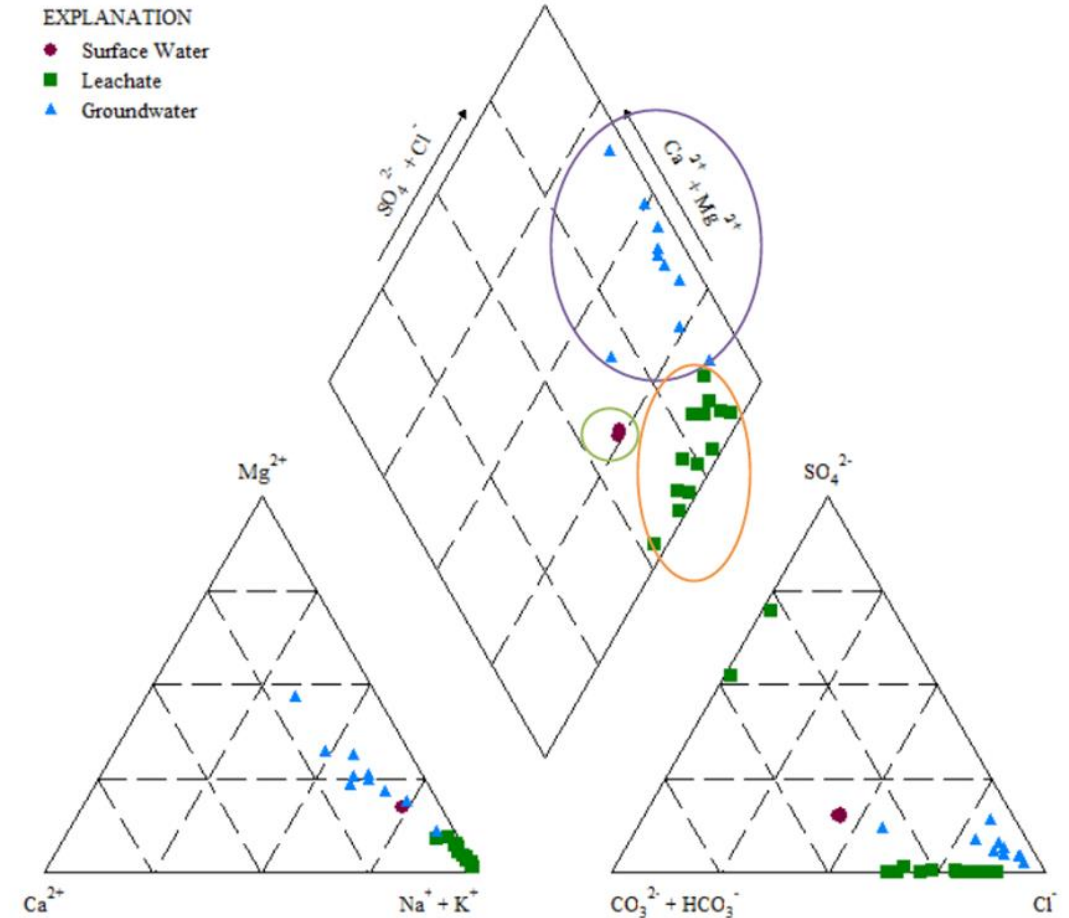
# Q7) PIPER PLOTS

Piper diagrams can be used to plot the hydrogeochemical signature of water samples (groundwater, leachate, surface water) by analysis of major ions.

By plotting leachate and groundwater, distinct differences can be shown between the chemical signatures for leachate compared to groundwater and where mixing may be occurring.

In the piper plot for Tullamarine, leachate samples (orange circle) are characterised by sodium, potassium and chloride. Whereas groundwater samples (purple circle) are characterised by higher proportions of magnesium and chloride. Where surface water samples (green circle) are still characterised by sodium and potassium, they do not have a dominant anion which leads to samples being more of a mixed type than the groundwater or leachate samples.

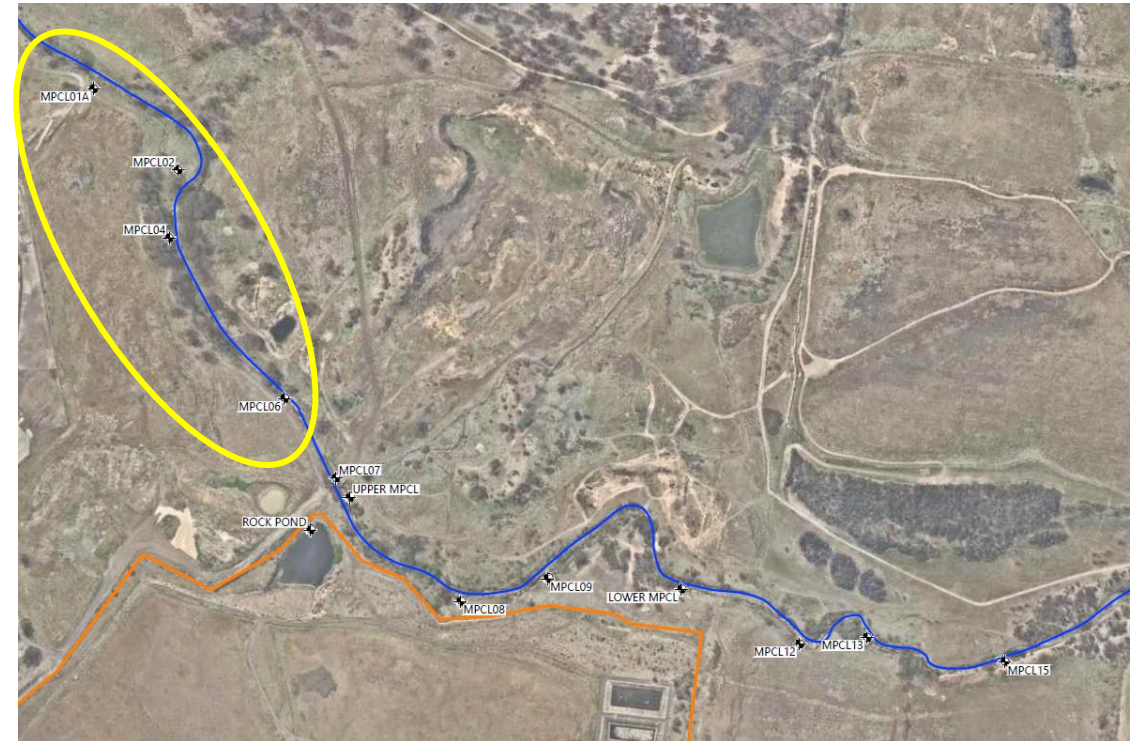
## Q8) PFAS IN SURFACE WATER

A number of these locations (circled in yellow) are upgradient from the site, indicating that the source of PFAS is likely to be upgradient from the site.

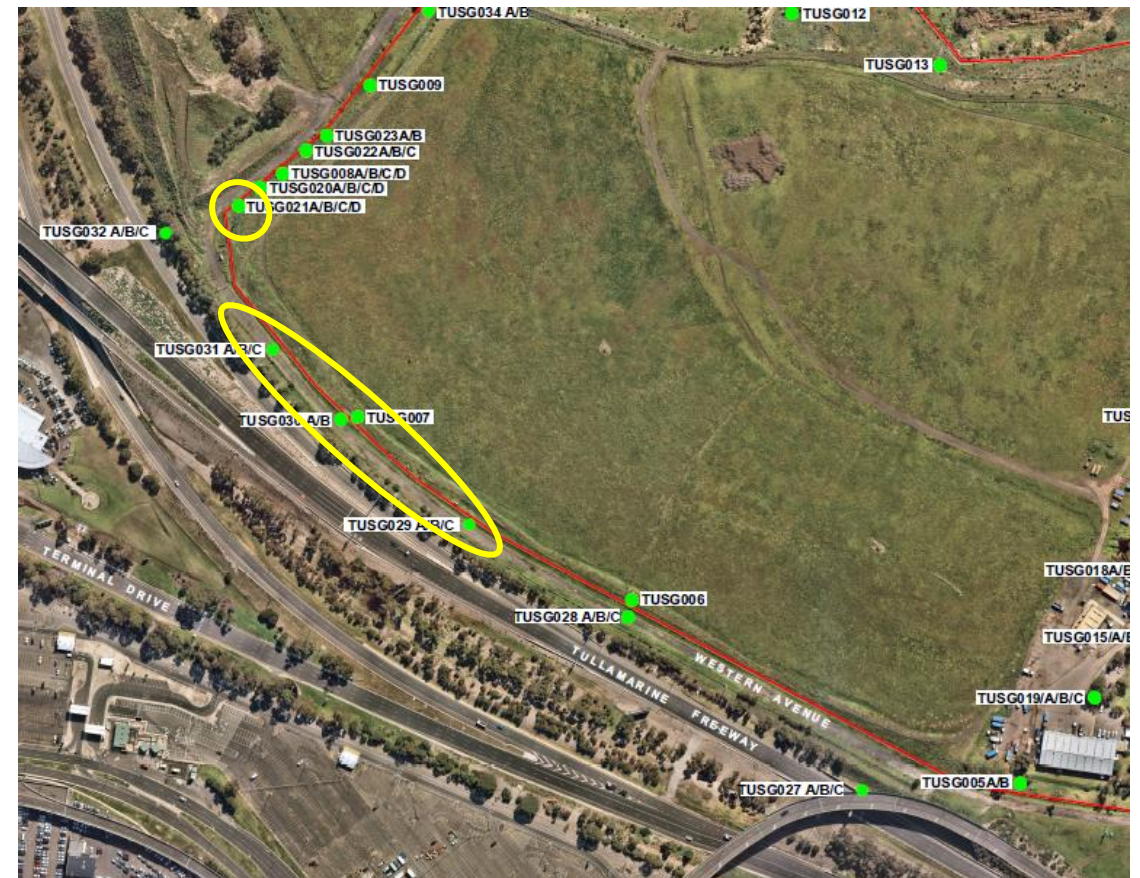
## Q9) METHANE IN PERIMETER GAS BORES

Of these bores, TUSG08C/D, TUSG18A/B, TUSG20B/C/D, TUSG22C were too close to the landfill mass.

The remainder (bores TUSG21C/D, TUSG29B/C, TUSG30B, TUSG31B) are on the southern boundary of the site (circled in yellow).
