# Annual Review

Erskine Park Waste Transfer Facility

Date:	November 2020
Prepared by:	Talis Consultants Pty Ltd and Cleanaway Waste Management Pty Ltd
Version:	Final

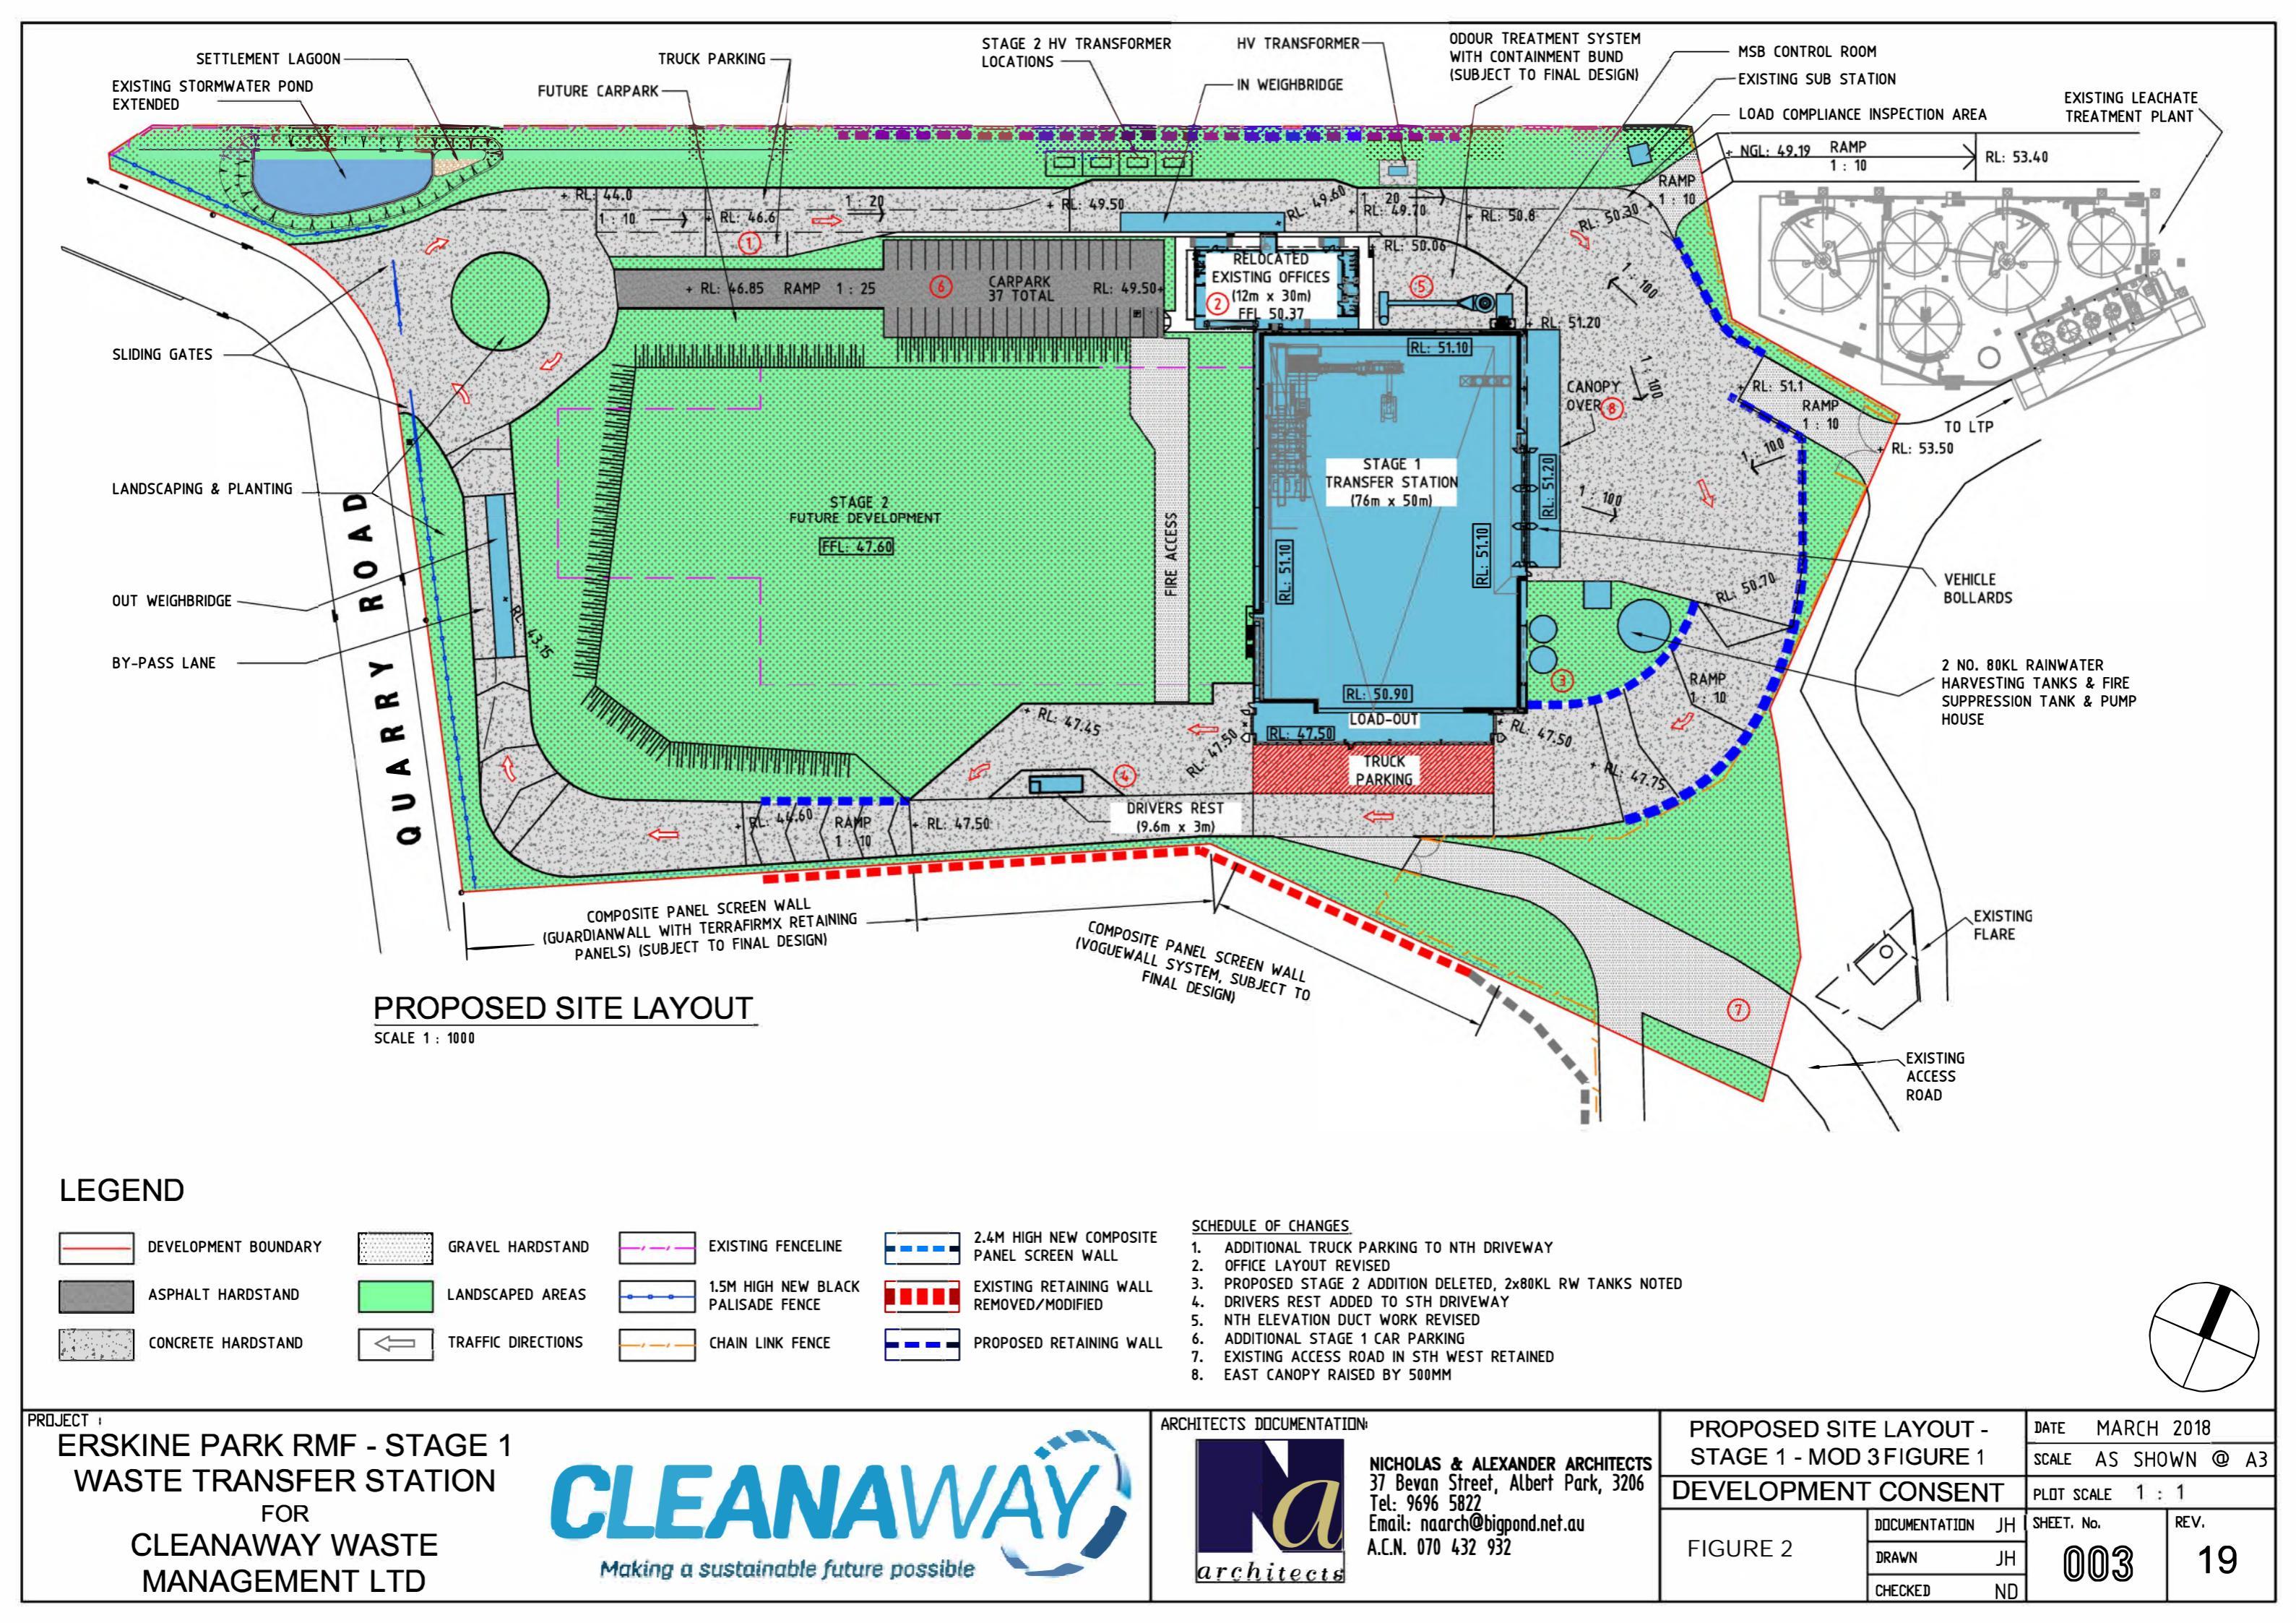
The layout of the WTS and site boundary (that encompasses Stage 1 and Stage 2 of the Development) is shown in **Figure 2.** The Site Layout for the Concept Plan and Full Site Development is provided in **Figure 3**.

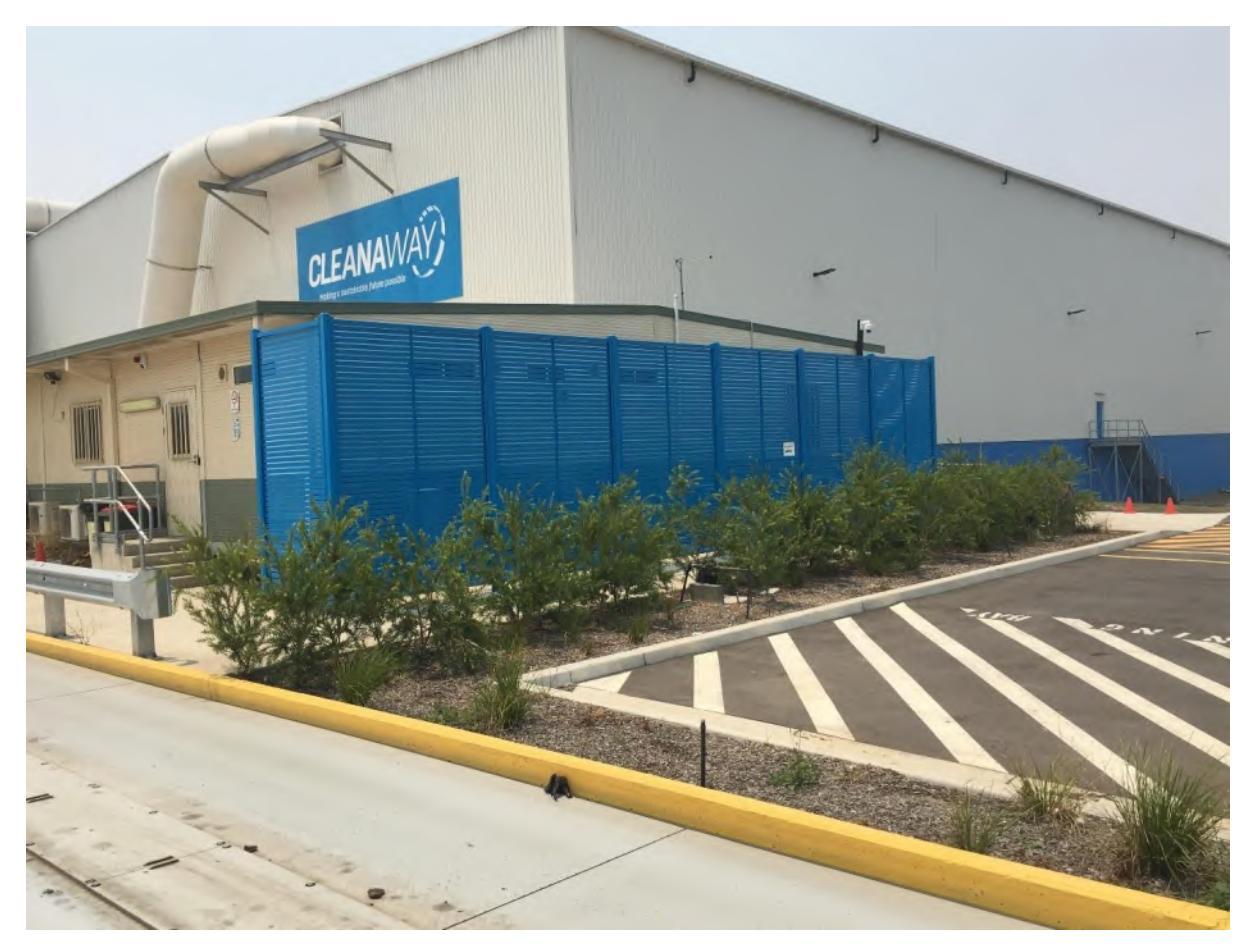
Photo 1 Screen and Landscaping Adjacent to the Site's Office

Management and mitigation measures were implemented at the site during the reporting period to minimise direct and indirect impacts on visual amenity, in accordance with the OEMP (SLR 2018a). The screen adjacent to the site office (refer to Photo 1, below) and the landscaping at the site was maintained during the reporting period.

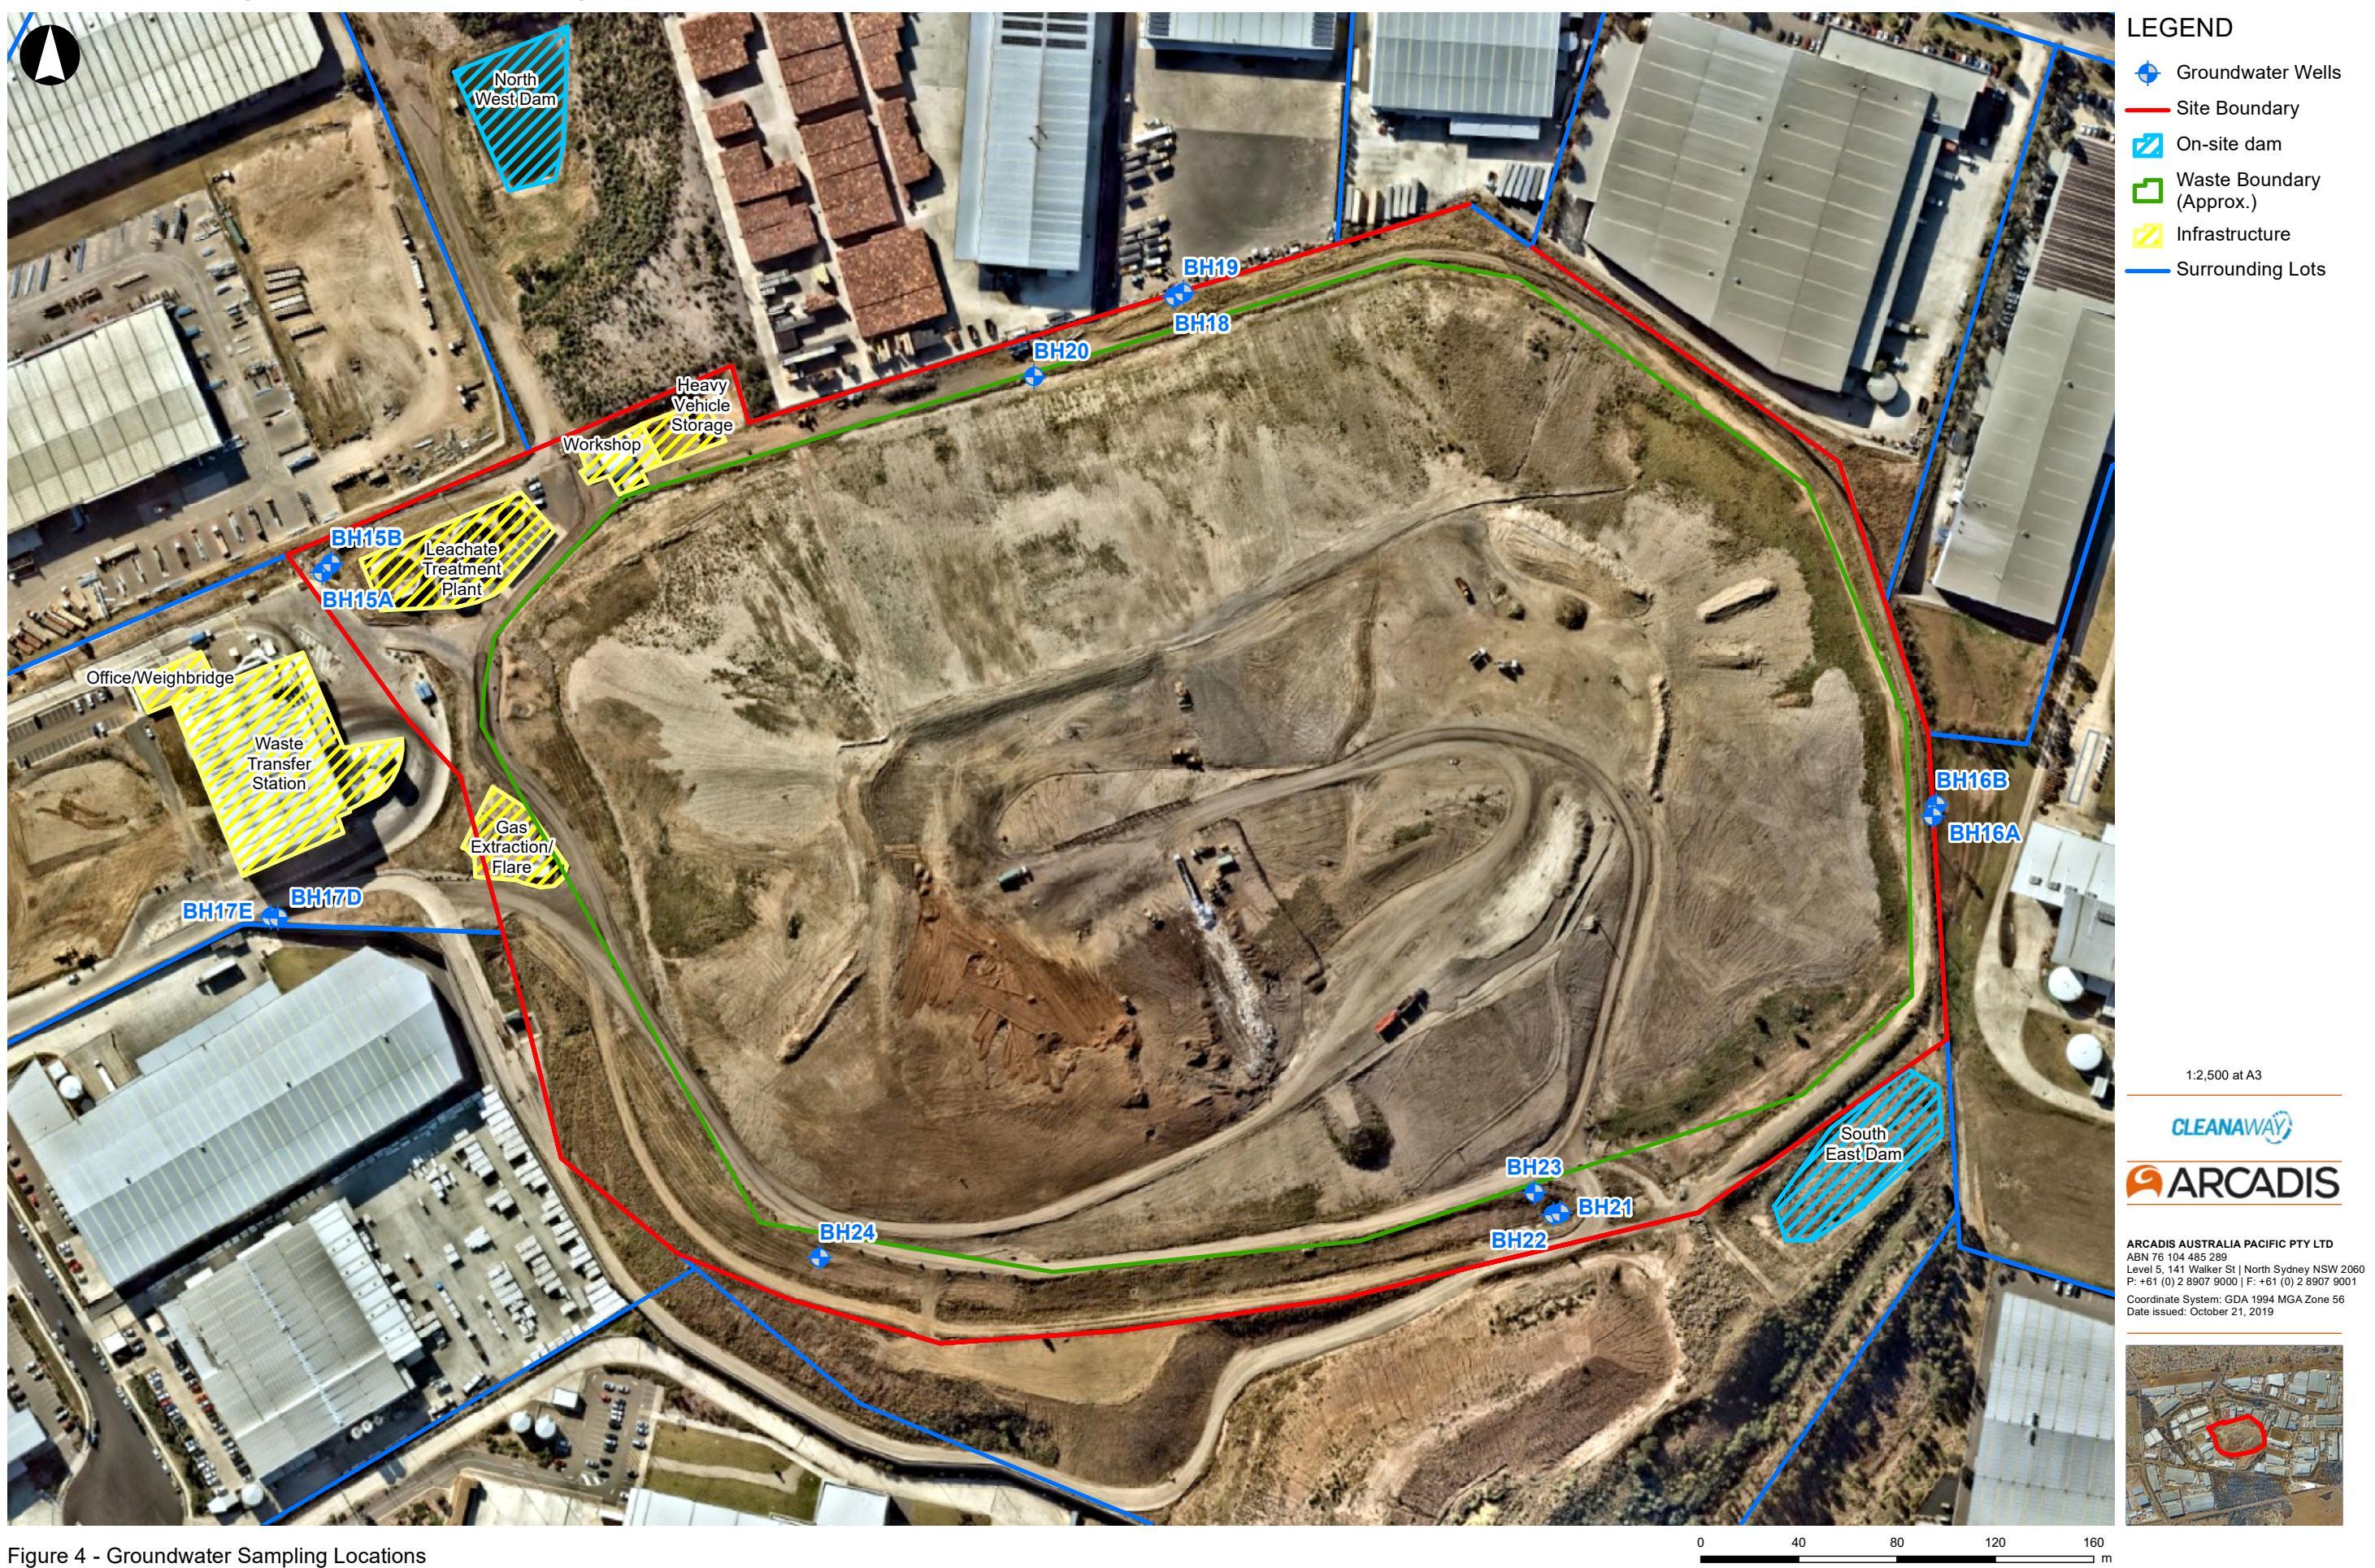
Monitoring is undertaken at 13 groundwater bores surrounding the Erskine Park landfill in accordance with the site's EPL (EPL 4865). Two of the groundwater bores (BH17D and BH17E) are within the site. Quarterly groundwater monitoring at these bores was undertaken during the reporting period. Samples were analysed for the same parameters as those monitored for the landfill groundwater monitoring program. Groundwater monitoring bore BH5 was replaced during the reporting period.
