# Annual Review

Erskine Park Resource Management Facility – Stage 1 – Waste Transfer Facility

| Date: | November 2019 |
| Prepared<br>by: | SLR Consulting Australia Pty Ltd and Cleanaway |

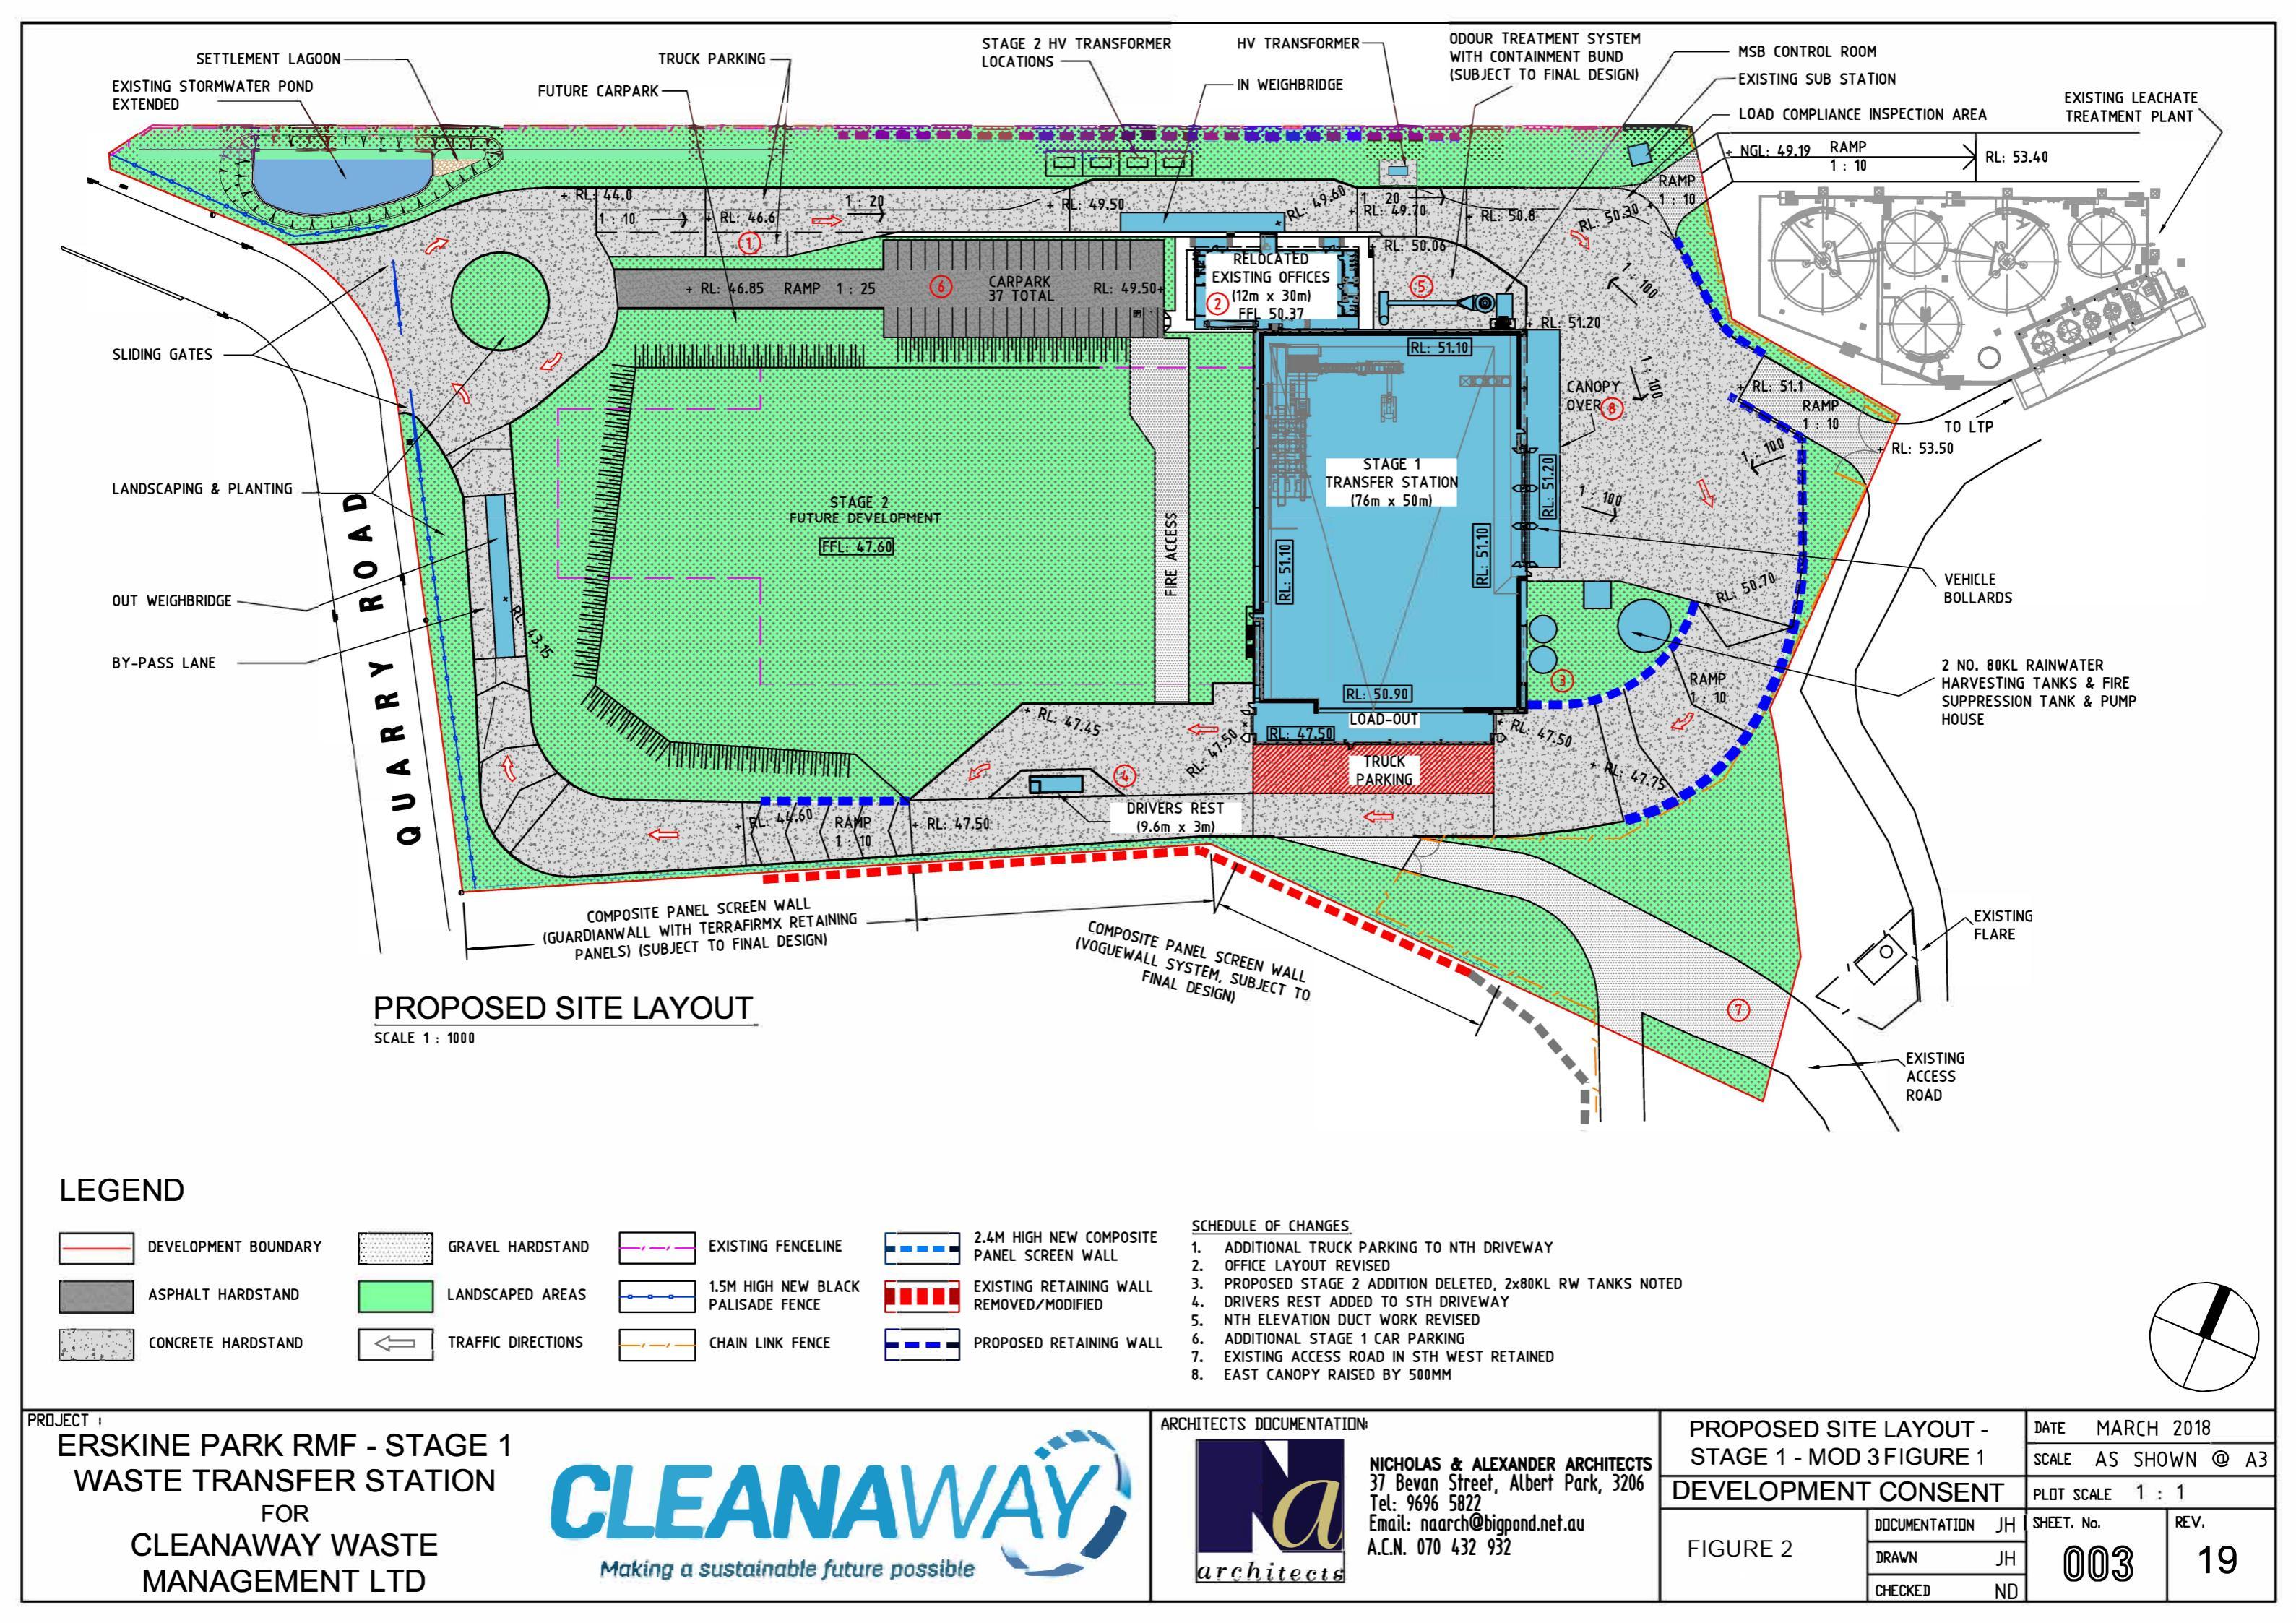
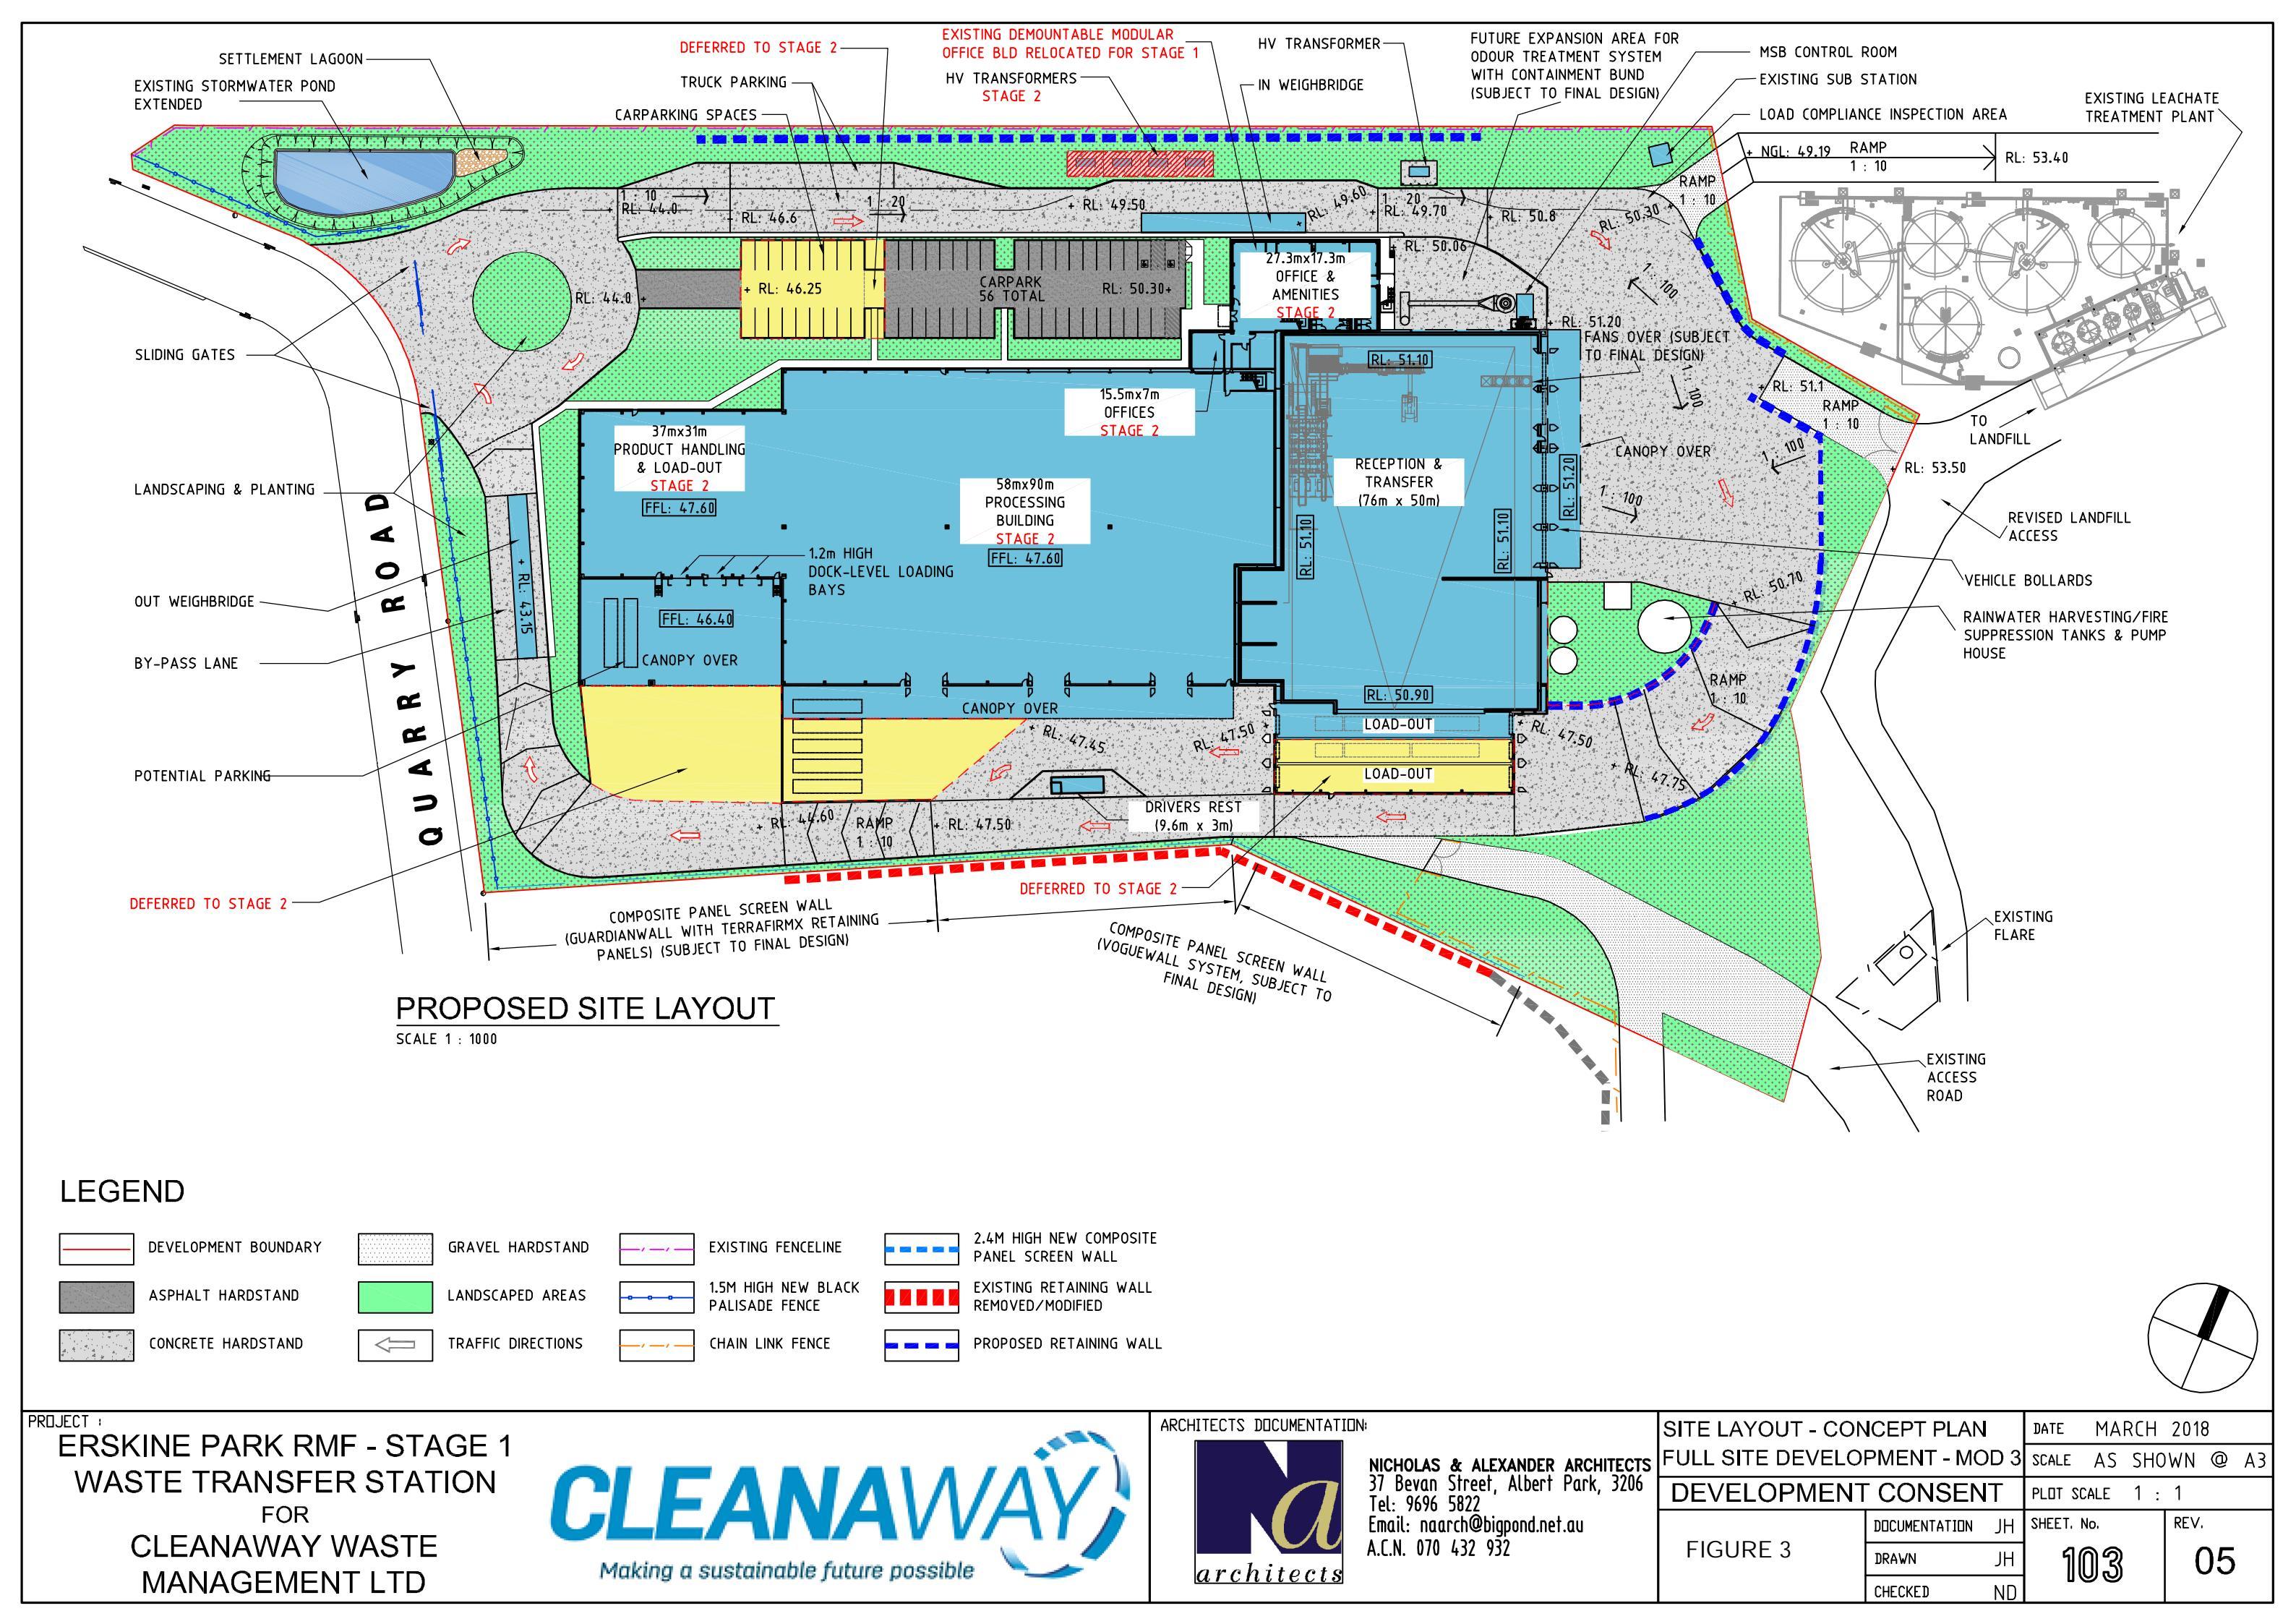
Waste delivery vehicles enter the site from the adjoining Quarry Road and weigh on the incoming weighbridge located adjacent to the office. Delivery vehicles then proceed to the eastern side of the building where they align with one of the roller shutter door entrances on the eastern elevation. The vehicles reverse through one of the rapid acting roller shutter doors, discharge their waste and then drive out of the building, down a ramp and proceed to the south of the transfer station towards the outgoing weighbridge, exiting the site onto Quarry Road. The majority of the material received is waste from commercial waste collection trucks, stationary compactor (packer) hooklift loads and side-loader collections (e.g. 240L mobile garbage bin collections from commercial premises).

Waste offloaded on the tipping floor is separated into two categories; putrescible and non-putrescible incl. wood, masonry, rigid plastics, and old corrugated cardboard. The non-putrescible waste is sorted for recycling, while the remaining waste is consolidated with the putrescible waste and transferred into transfer vehicles by a front-end loader which lifts the material over a wall opening for top loading.

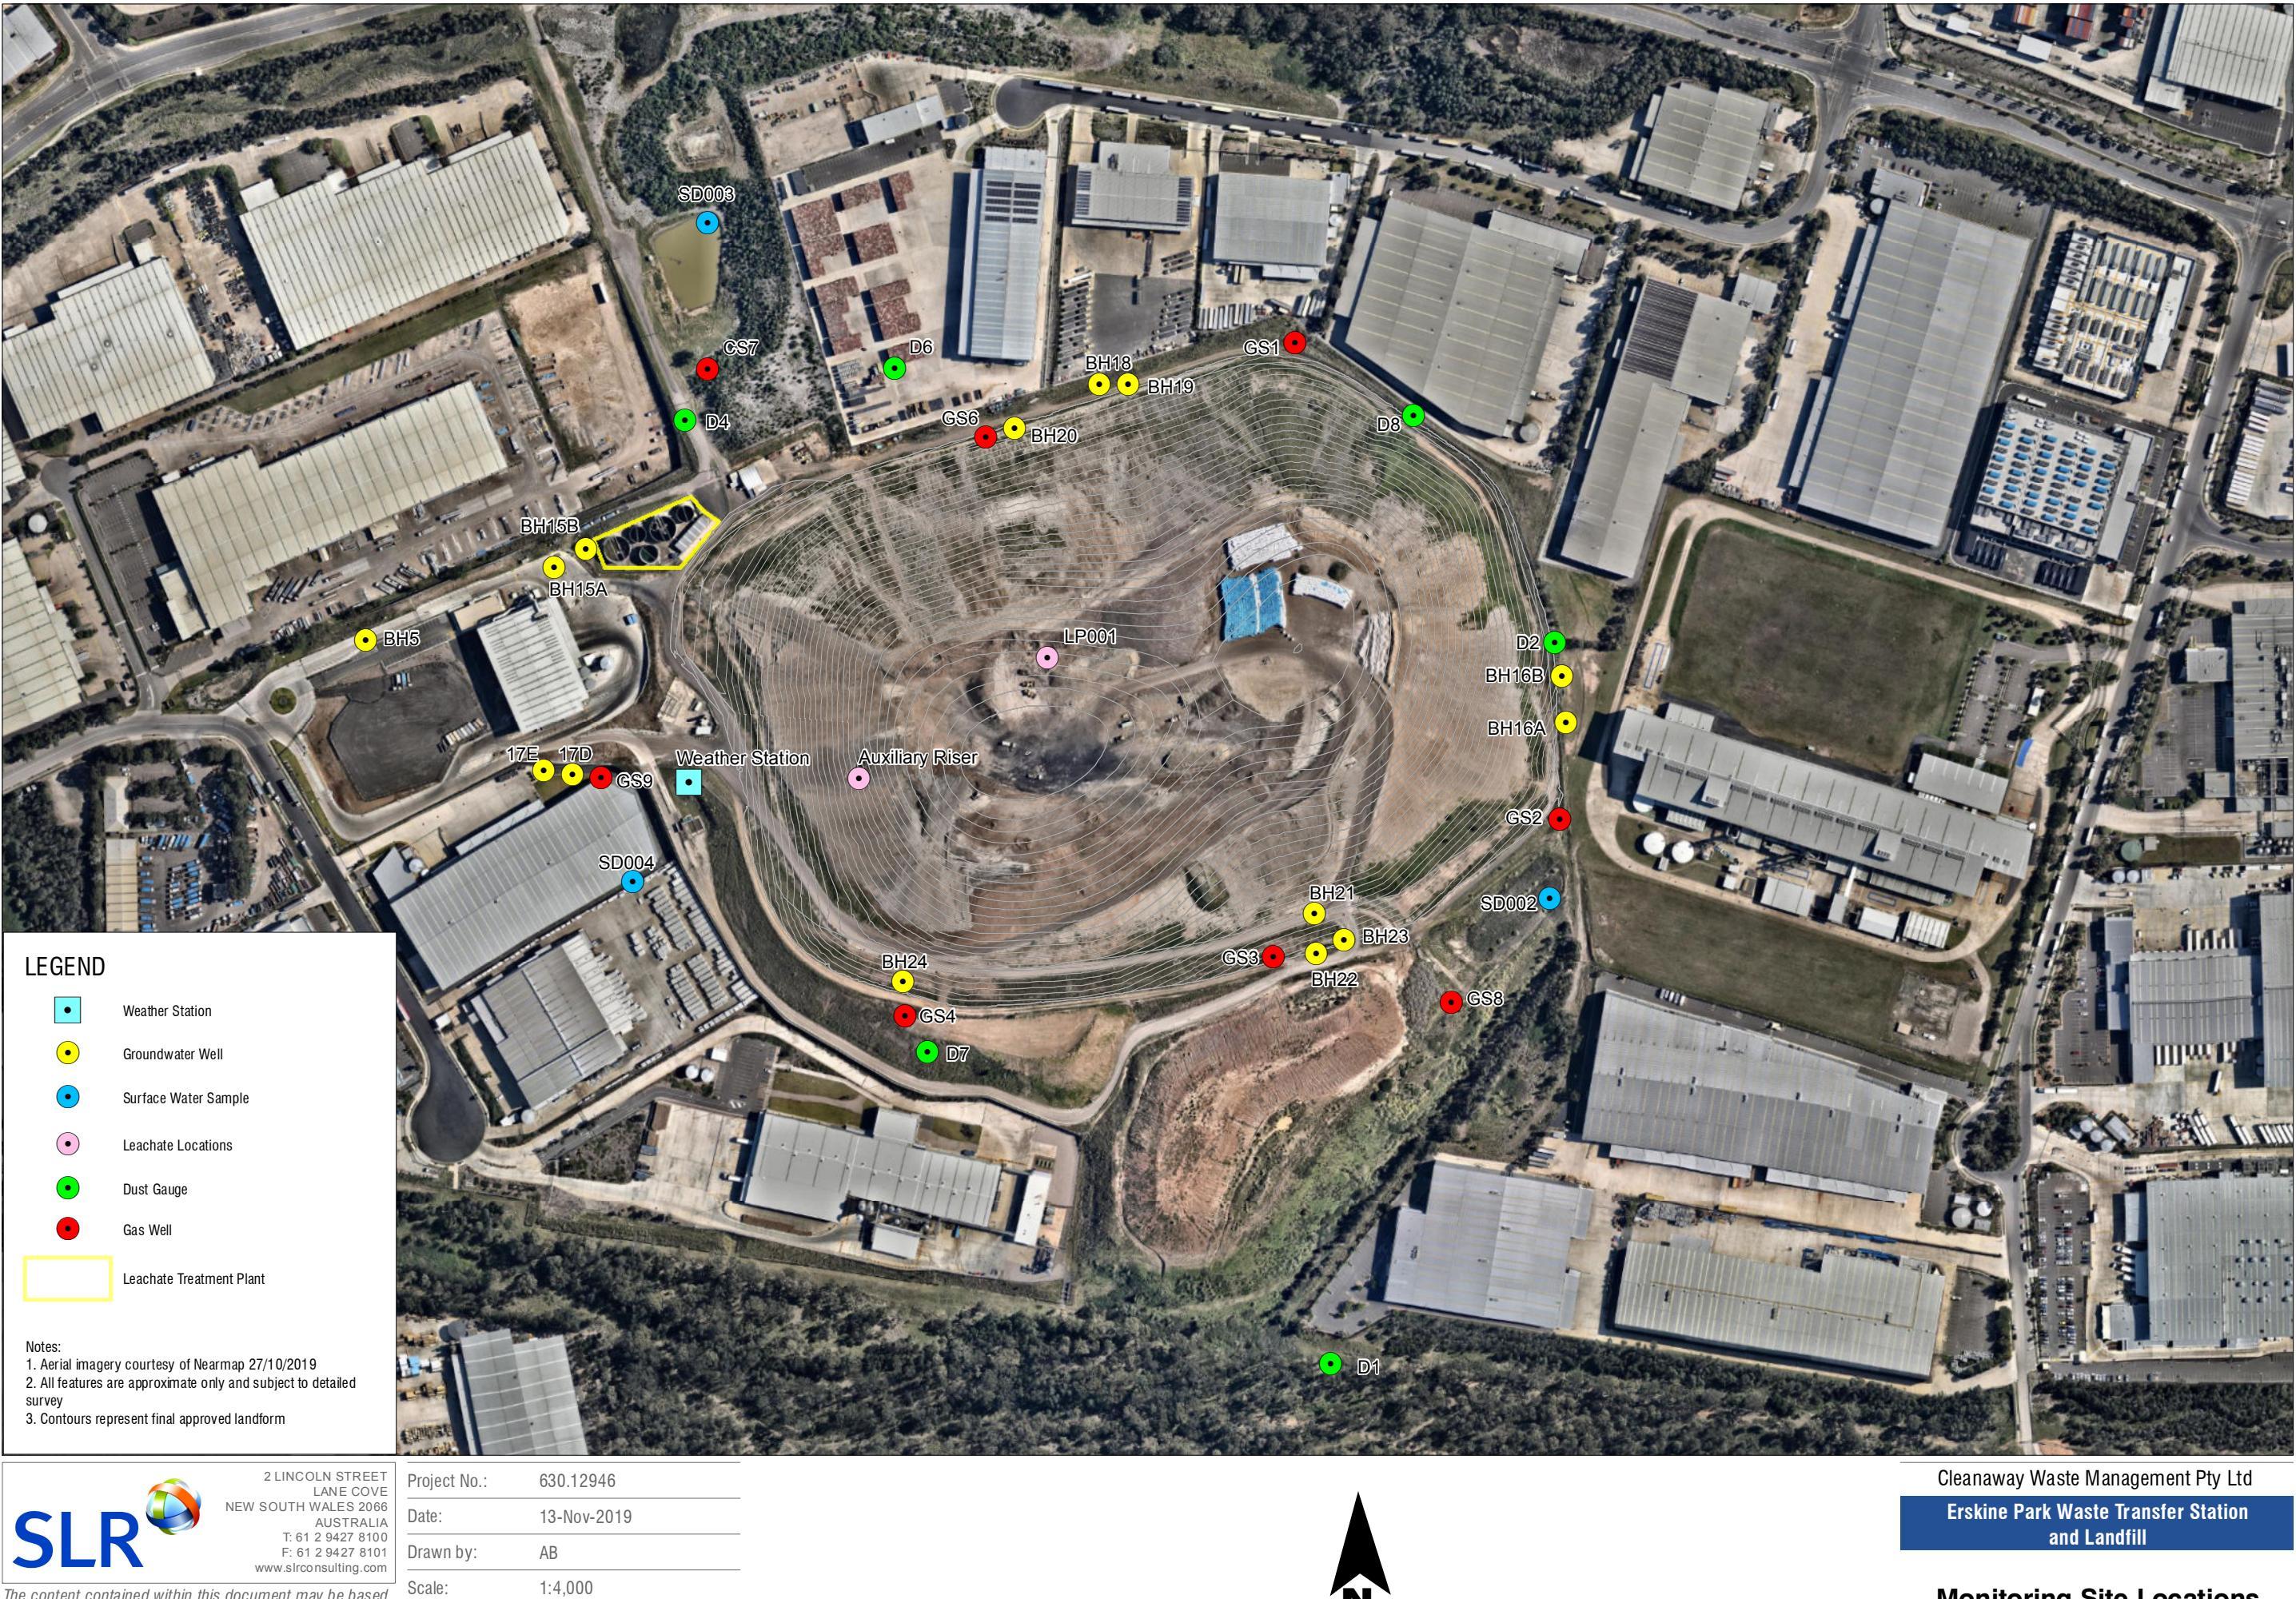
Condition A9 (Schedule C) of SSD7075, as modified, and Condition M2.2 of EPL 20986 require continuous meteorological monitoring at the site. Erskine Park has established a weather station at the site. The weather station is located in the south-east corner of the site, adjacent to the landfill, as shown on **Figure 4**.

A meteorological station has also been installed at the site (refer to **Figure 4**) that complies with the requirements in the latest version of the Approved Methods for Sampling of Air Pollutants in New South Wales. Cleanaway continuously operated the meteorological station during the reporting year, and maintained records of meteorological data.

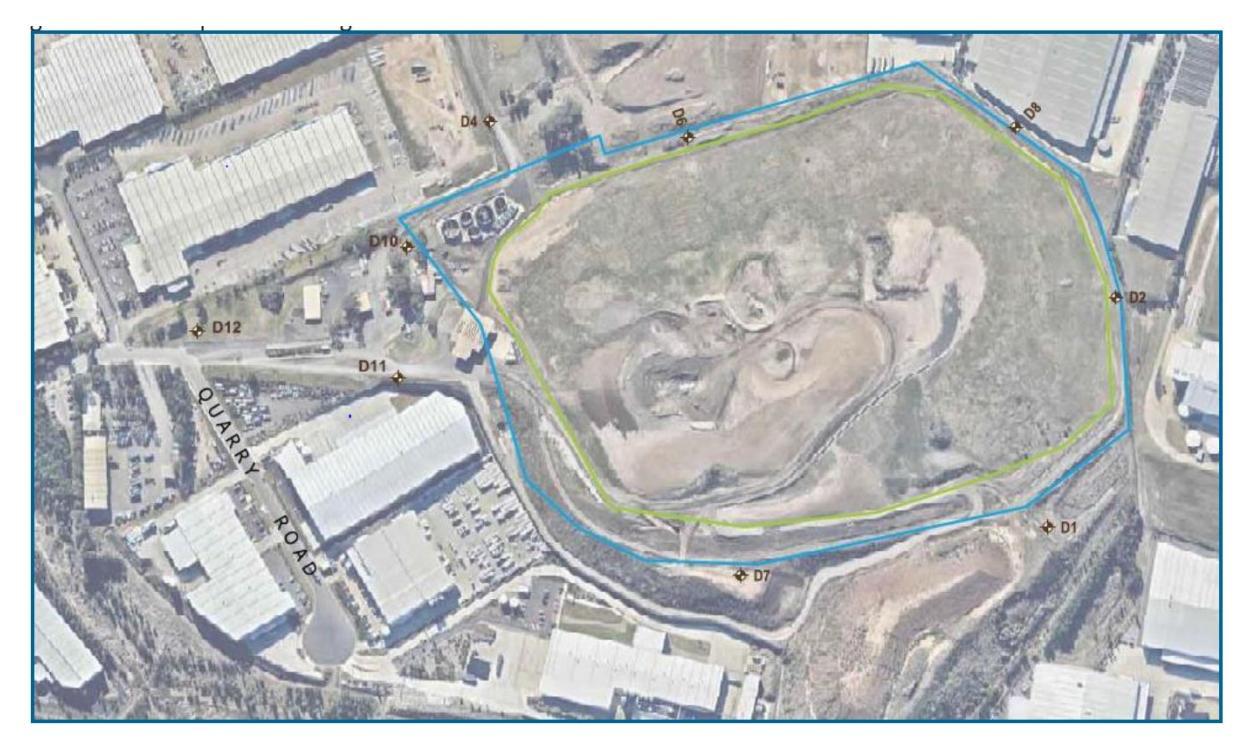
**Figure 5 Location of Dust Monitoring Sites**

A dust monitoring program was undertaken at the site while construction works were undertaken, in accordance with the Statement of Commitments requirements in Appendix 3 of SSD 7075, as modified. Three depositional dust gauges were set-up at the site in January 2018. The first at the north-western corner of the site (D10), the second at the wheel wash (D11) and a third entrance of the site (D12) for the purposes of the site's monitoring program (refer to **Figure 5)**.

During the reporting period monitoring site D12 was replaced, as this was removed during the previous reporting period (October 2018), due to construction works. Dust monitoring gauge D11 was also removed during the same construction works, but was not replaced.

Depositional dust was monitored at these sites on a monthly basis, during construction, in accordance with Australian standard 3580.10.1-1991. Dust monitoring was not required to be undertaken during site operations. Samples collected from the depositional dust gauges were analysed for total solids, soluble matter, total insoluble matter, combustible matter and ash content. It should be noted that dust limits have not been set for the site by either the site's Development Consent or EPL.

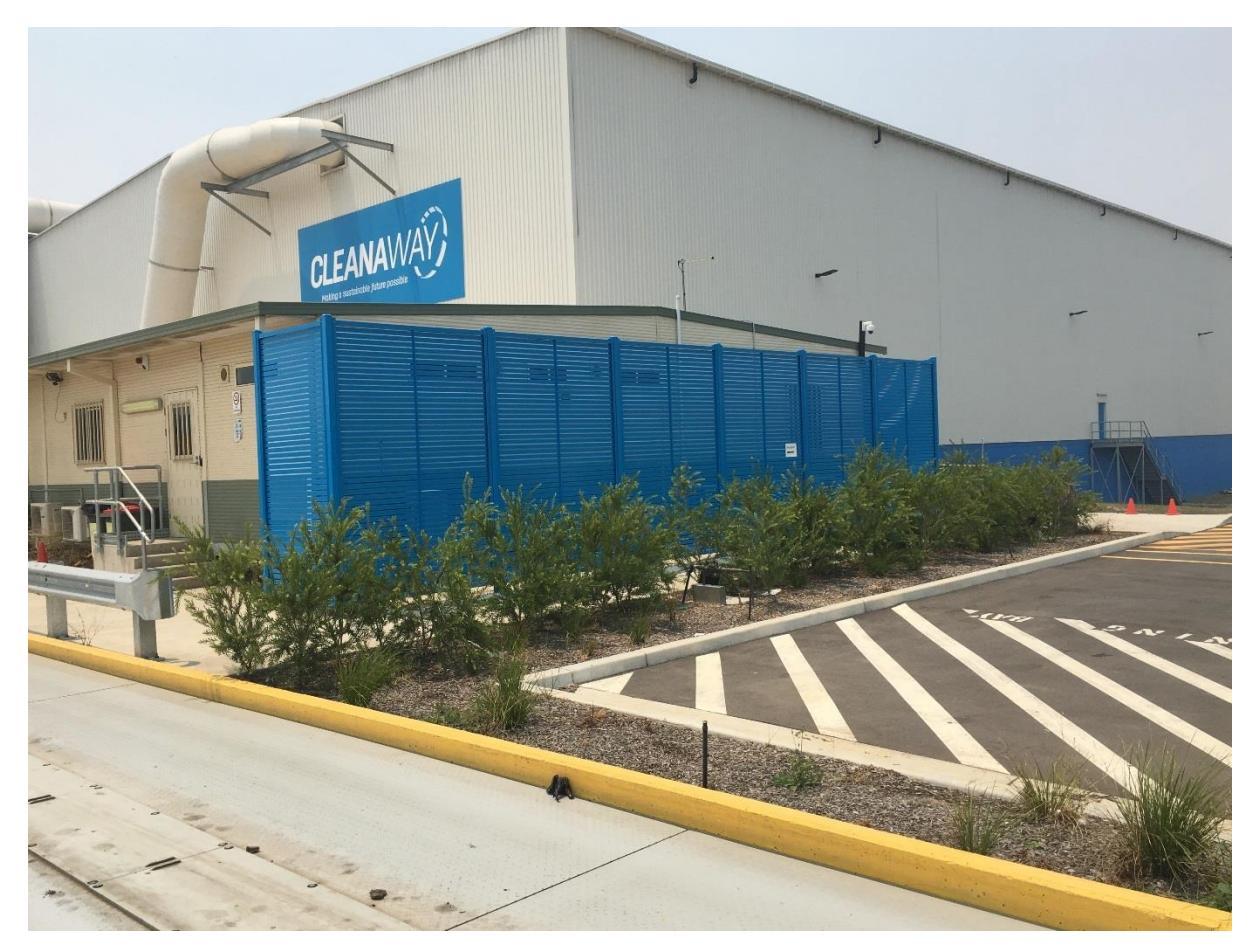
- A 3-metre screen was installed on the western side of the site office;
- Trees and shrubs were planted at the site, in accordance with the Landscape Plan; and
- The office was painted the same external colour scheme as the main transfer station building.

Photo 1 Screen and Landscaping Adjacent to the Site's Office

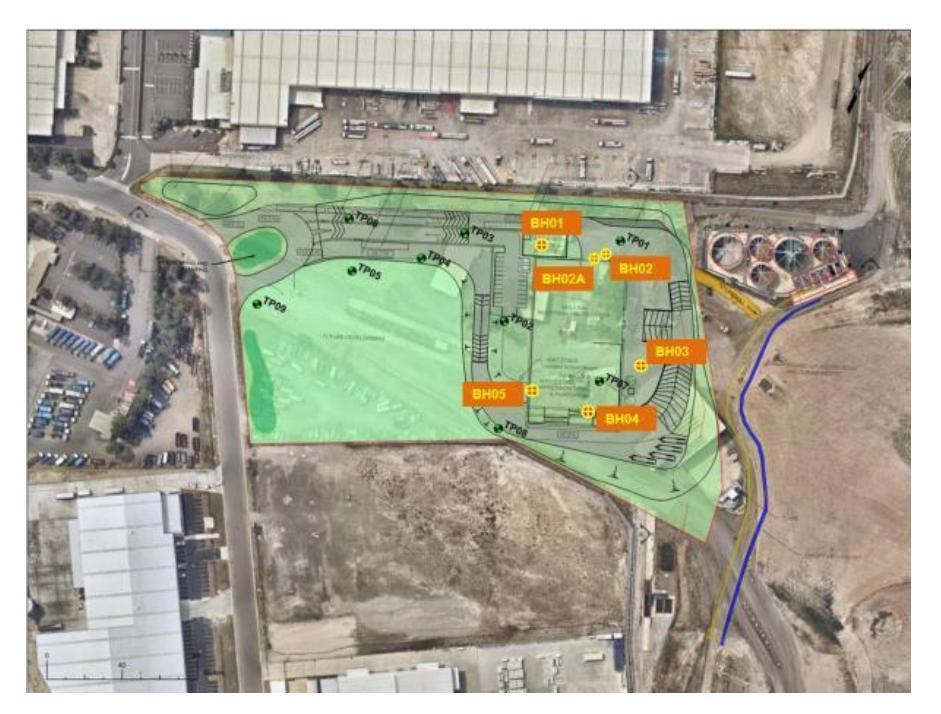
#### Figure 6 Site Plan Showing Borehole and Test Pit Locations

A soil, geology and contamination assessment was undertaken for the EIS (SLR 2015a). A total of nine (9) test pits were excavated. The test pit locations are presented in **Figure 6**. Visual assessment of material exposed during excavation of the geotechnical boreholes (test pits) and subsequent laboratory analysis of samples concluded there was no potential source or evidence of contamination within the site. These predictions made in the EIS were confirmed, with no contamination discovered at the site during the reporting period.
