17 March 2015

New Chum Waste Disposal Facility Environmental Monitoring Annual Reporting Summary for January to December 2014

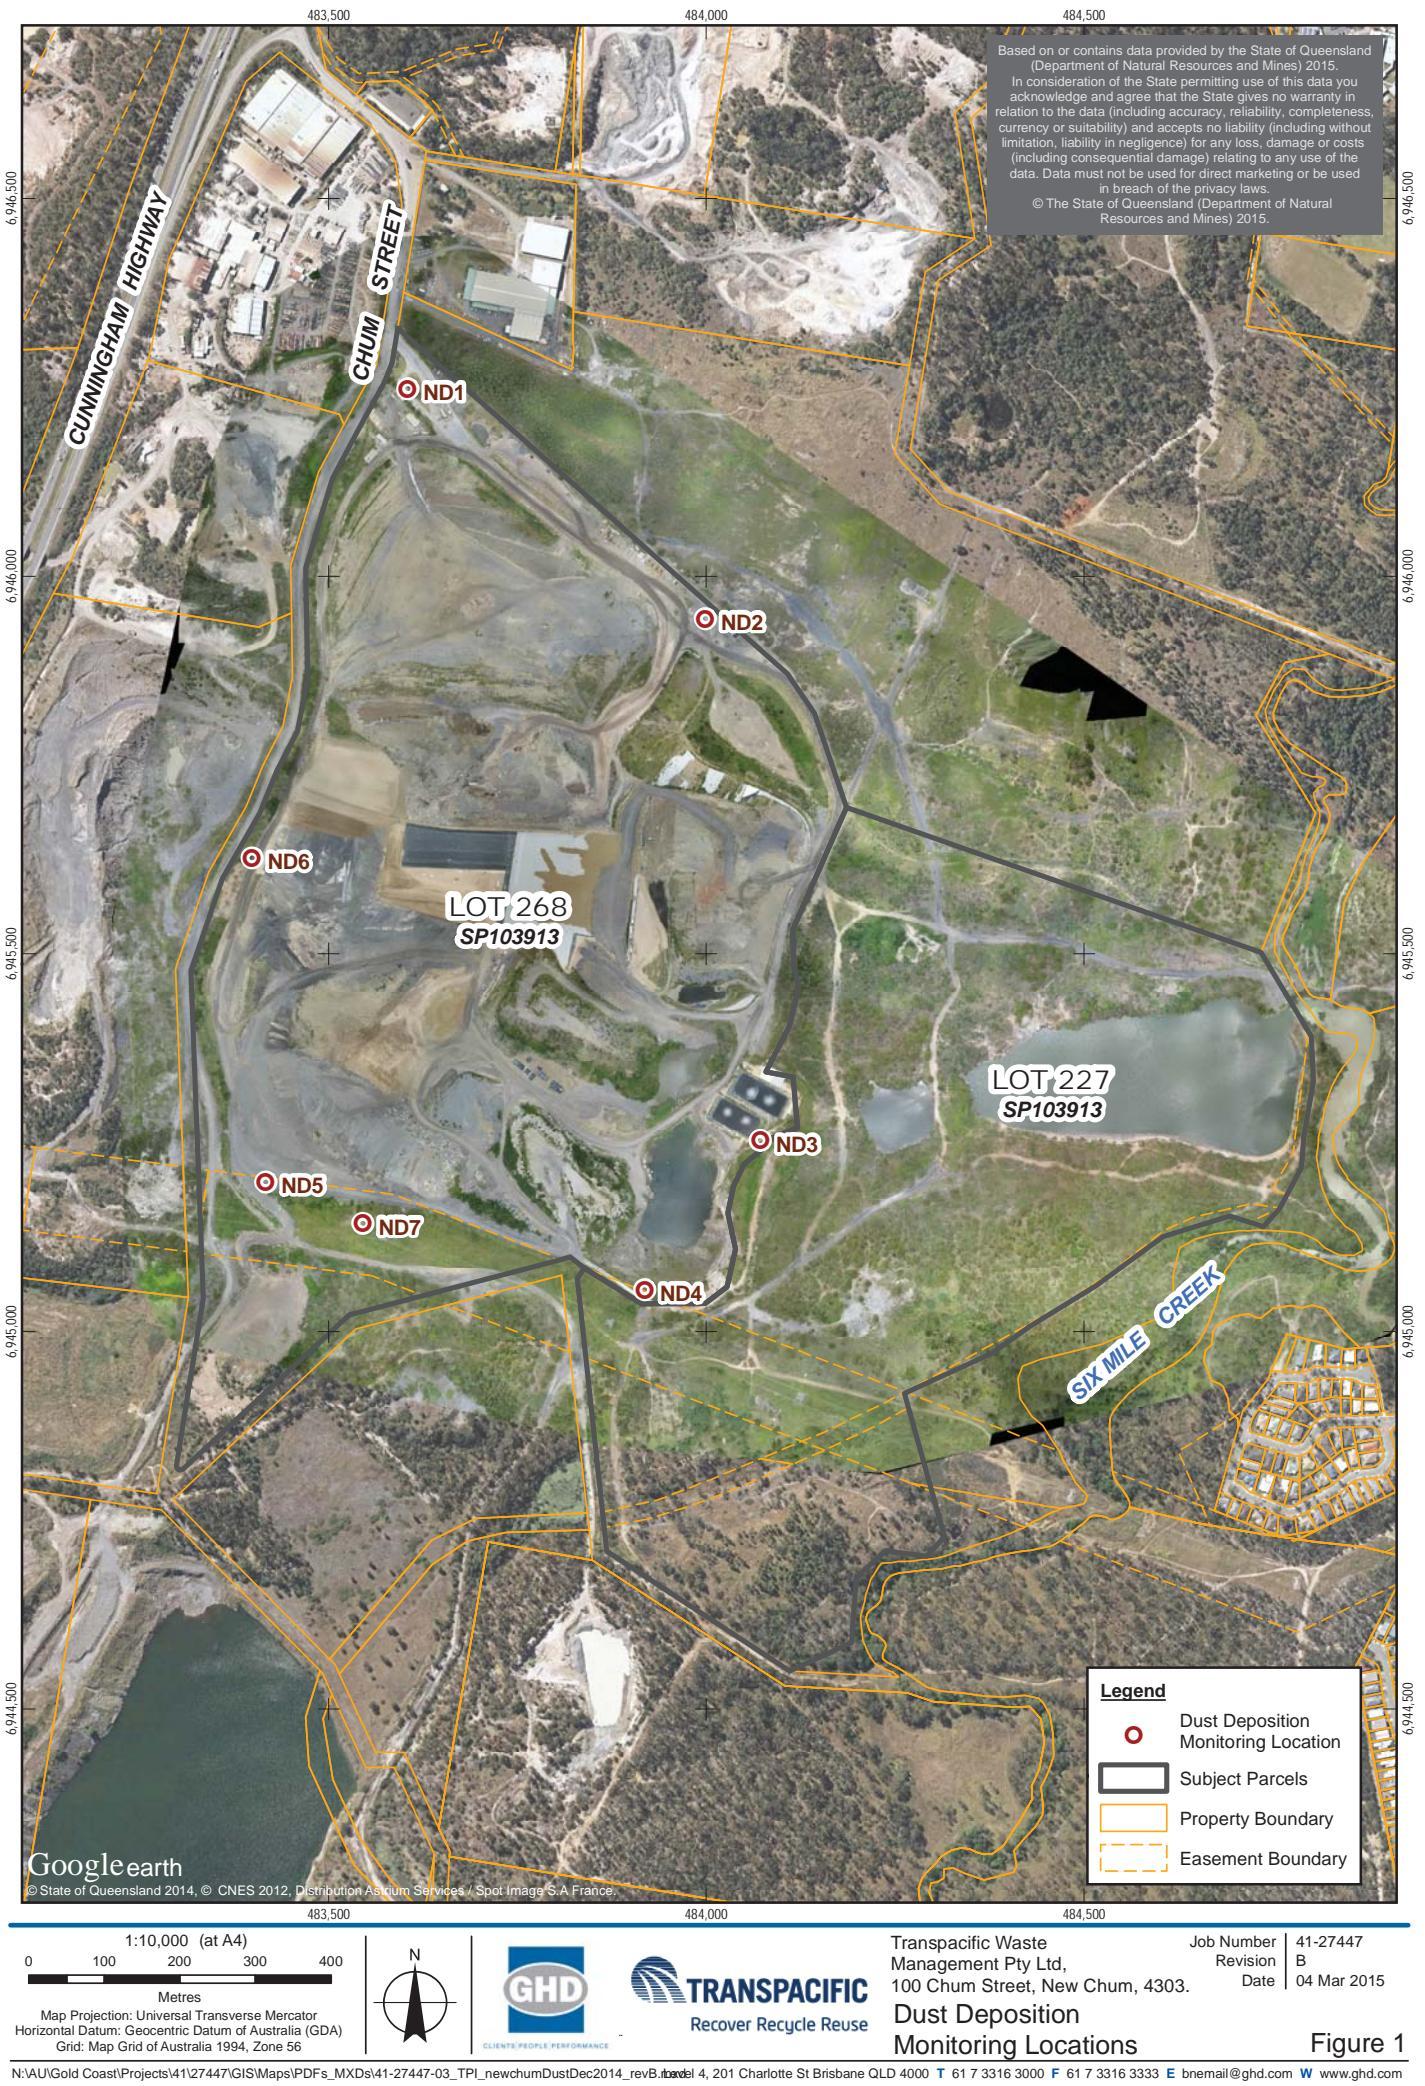
GHD installed six dust deposition stands (ND1 to ND6) and conduct monthly dust deposition monitoring at the New Chum WDF over a period of four months, between 11 April 2014 and 12 August 2014. Further to this, a seventh dust deposition stand (ND7) was installed to obtain baseline dust levels prior to the installation and operation of a concrete crushing facility, and undertake ongoing monthly dust monitoring of all seven locations as of November 2014 to compliment the Site's environmental monitoring program.

Data Source: DNRM - Cadastre (2010), Google Earth Pro - Imagery Date - Sept 2013, addition client supplied imagery (21 Jan 2015), GHD - Dust Monitoring Sampling Locations (2014). Created: JVC

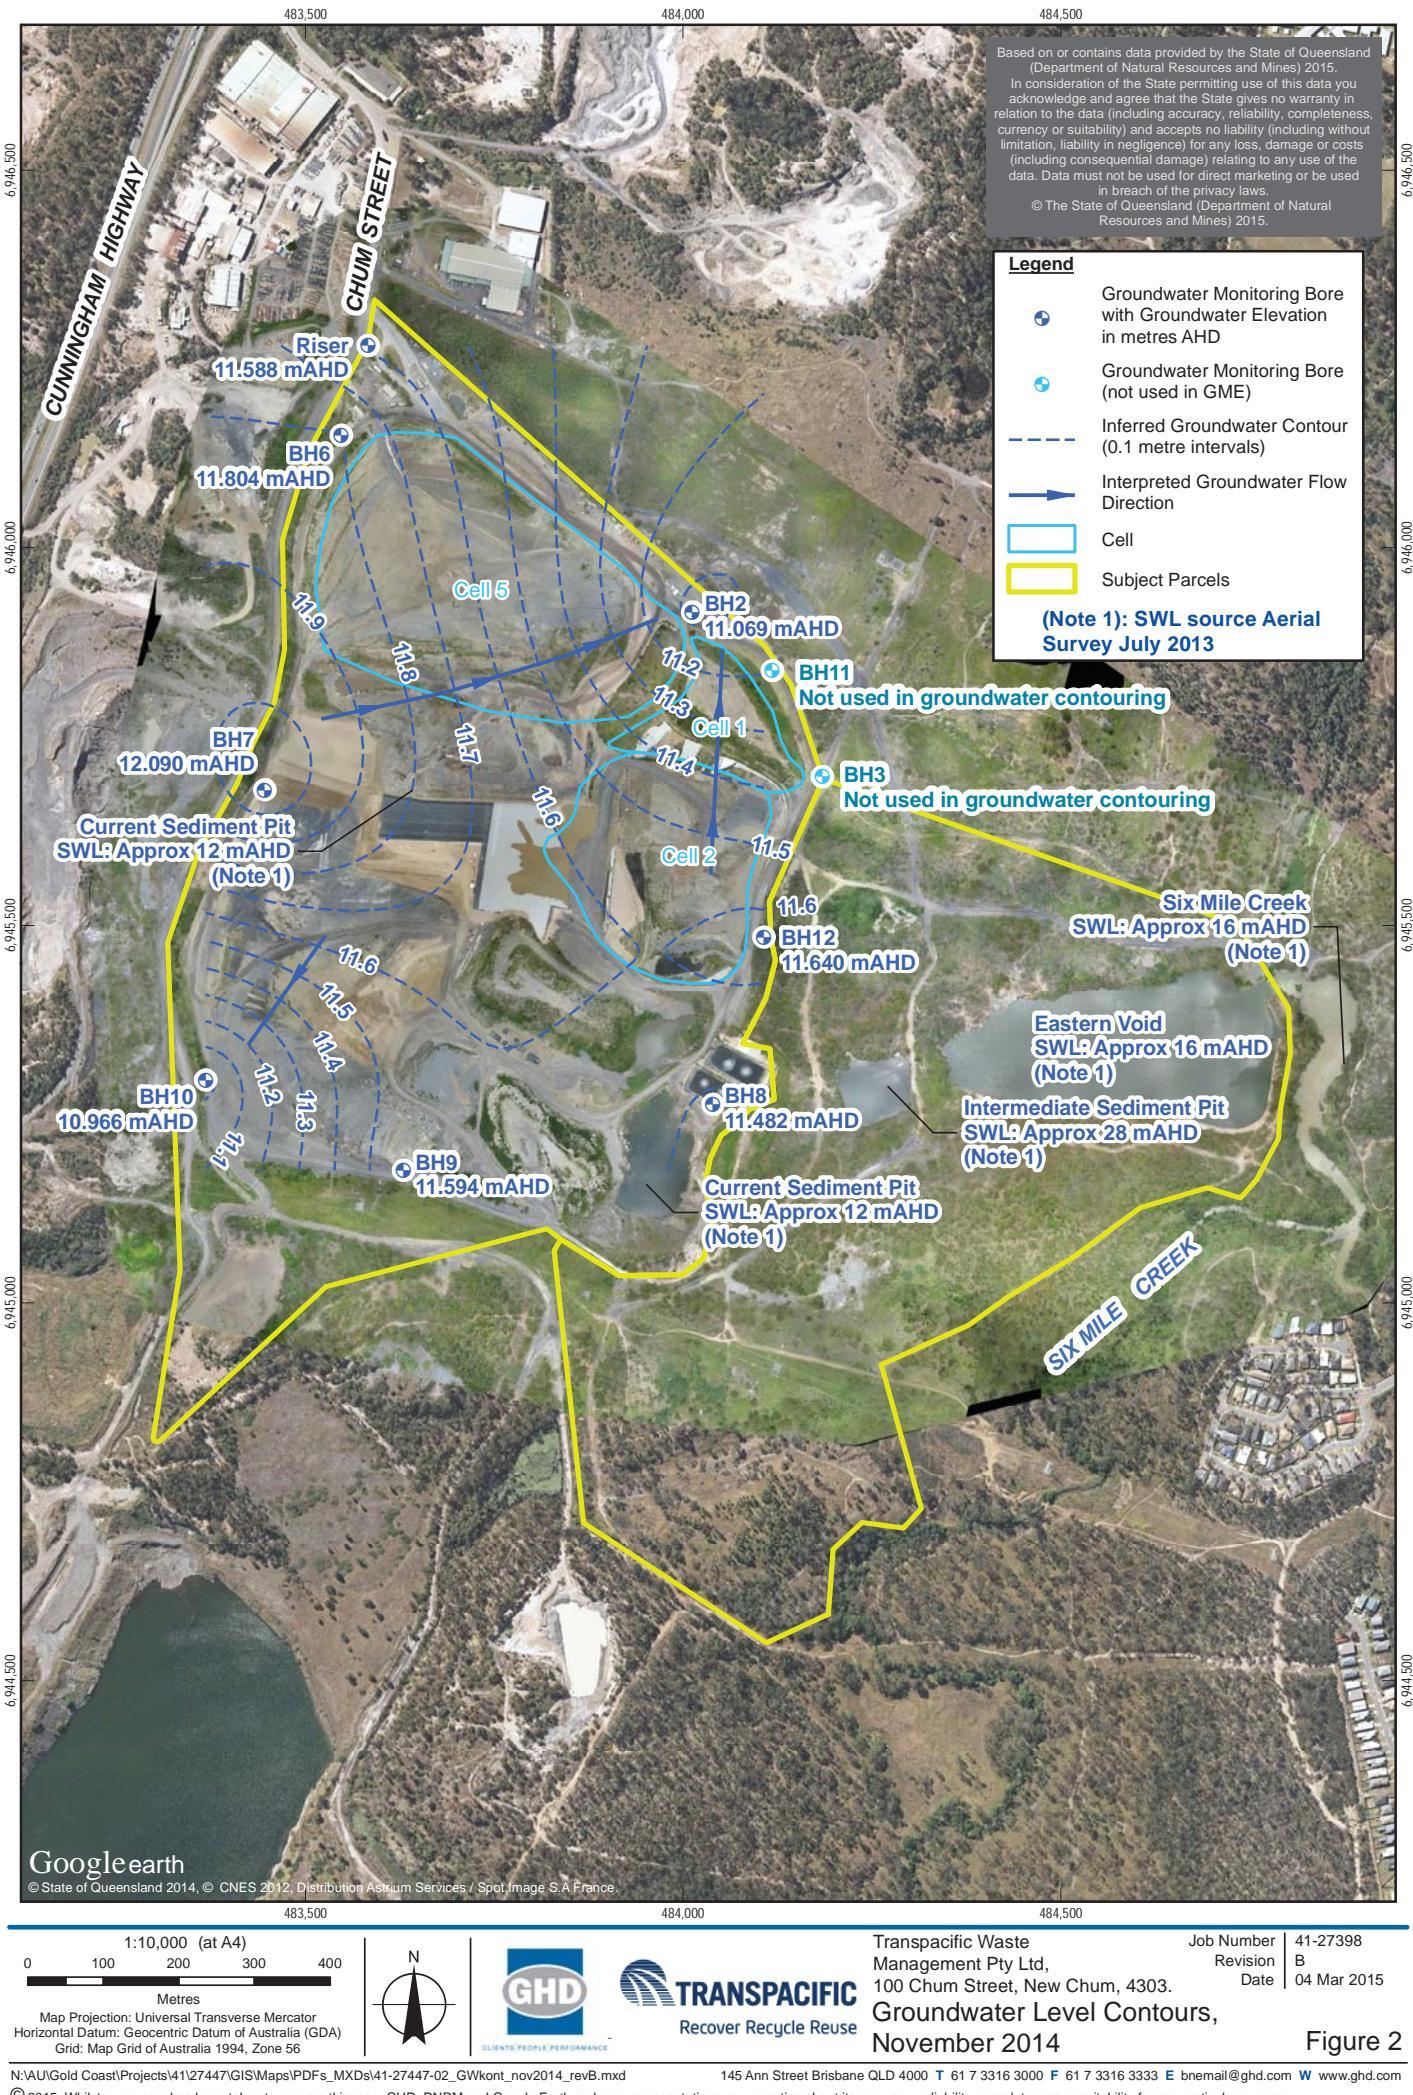
A review of the hydrogeology at the site was undertaken in the 2014 reporting period by GHD to assess the adequacy of the groundwater monitoring network. The review indicated that groundwater flows towards the east and then the north east, i.e. towards the Brisbane River. As such, monitoring well BH02 was found to be downgradient of Cell 5 and monitoring wells BH05 to BH10 were found to be upgradient of the landfill. Following the 2014 hydrogeological review, two additional inferred downgradient wells BH11 (adjacent to Cell 1) and BH12 (adjacent to Cell 2) were installed along the eastern property boundary. Whilst groundwater contours infer BH11 is downgradient of Cell 1, additional assessment of BH12 is required as this monitoring well (like BH03) may be hydraulically separated from the waste mass (refer to GHD document 41/27447/7240 Rev 0).
